Shikoku Electric Announces Cause of Cracks at Ikata-1

On December 1, the Shikoku Electric Power Co. announced the cause of the tiny cracks that had been found in the outlet piping of the coolant storage tank at its Ikata-1 NPS (PWR, 566 MW) nine days in earlier during the unit's 22nd periodic inspection. The company also outlined the actions it plans to take to deal with the problem.

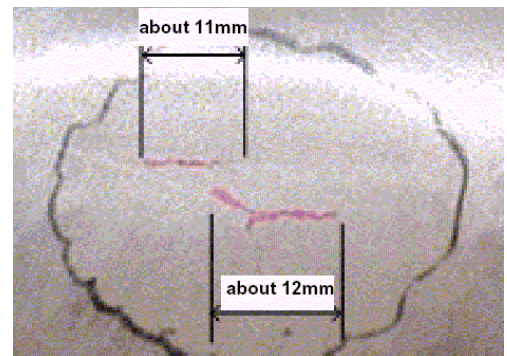
- (1) The outside surface of the piping where the cracks were found bore rust, as well as a rectangularly-arranged extraneous substance that appeared to be glue from tape.
- (2) There were two linear cracks - one about 12mm long and the other some 11mm long - away from the immediate vicinity of welding.

Further investigations supported the assumption that stress-corrosion cracking, prompted by a chloride compound, had created the tiny cracks.

The two linear cracks

The maximum depth of the cracks was 3.1mm, measured from the outside surface of the piping. The pipe wall thickness was 6.8 mm - even at its thinnest section beneath the cracks - a figure much greater than the permitted minimum of 0.07mm. That meant that pipe strength was not the problem. The inspectors then turned their attention to another piping system installed along the ceiling above the cracked piping section. The piping is used for ordinary water for internal use, and was not in use at the time the cracks developed. They found corrosion in the welded part of that piping, as well as signs of water leakage. Marks on other set of pipes underneath the ceiling pipes (specifically, the return piping to a coolant storage tank) were recognized as having been created by water dripping down from the ceiling piping.

Under those circumstances, the company assumed that a chloride compound in the leaked water from the corroded piping accumulated on tape that had been attached to the outlet piping during work in the past. Although the tape had been removed, the glue from the tape remained on the outlet piping, and the chlorine compound reacted with it in such a way to cause the stress-corrosion cracking.

According to the December 1 announcement, Shikoku Electric will replace the portion of the piping that contained the cracks. It will also remove the piping near the ceiling, or fix it in such a way that it does not leak onto the other piping systems below.
