The Present Status and the Future Of Fukushima Daiichi NPS

April 18th, 2012
Zengo Aizawa
Tokyo Electric Power Company

The Earthquake and the Tsunami of the 3/11/2011

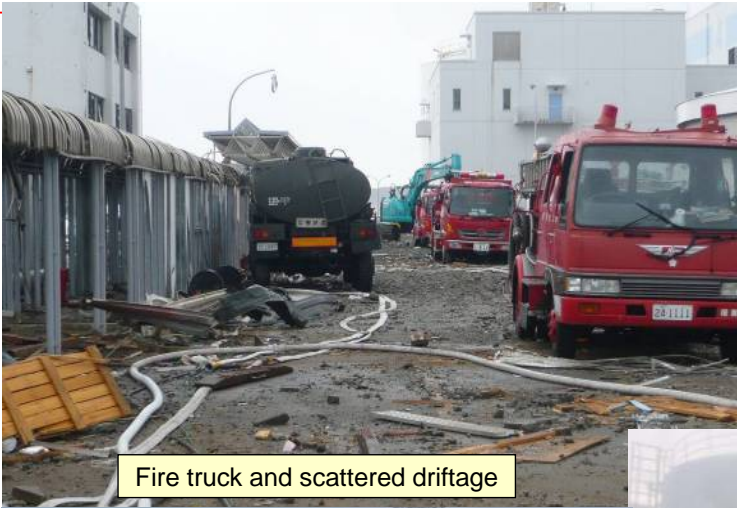
Fire truck and scattered driftage

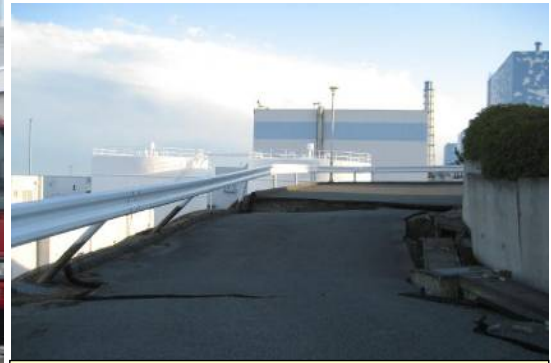
Wide-open cracks on the road blocking the transportation

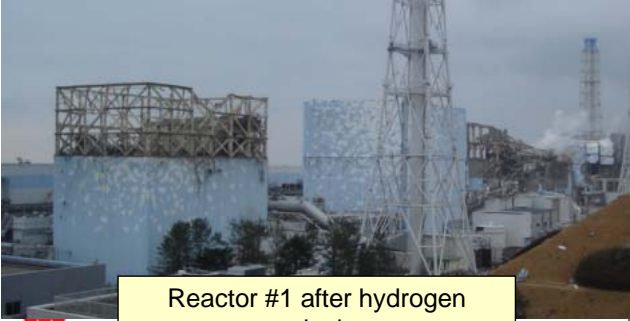
Reactor #1 after hydrogen explosion

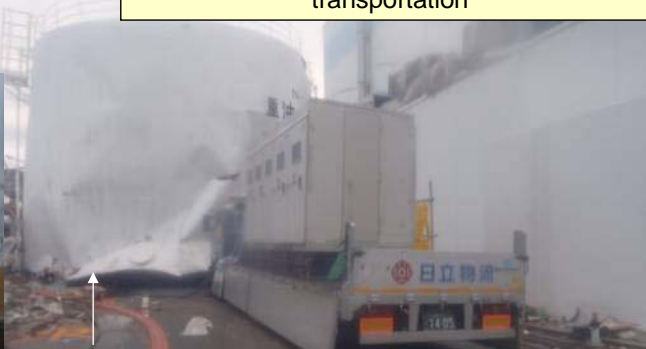
Heavy oil tank washed away by the tsunami and blocking the road

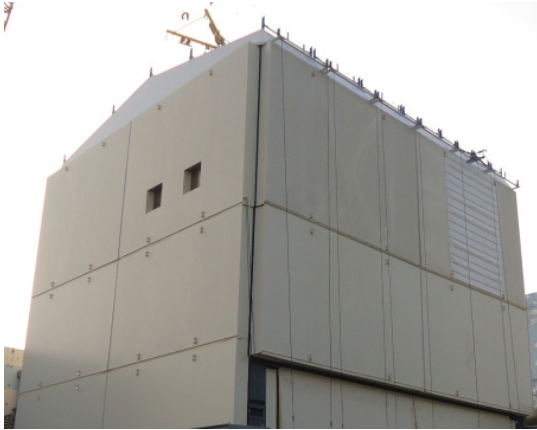
Installation of the reactor building cover on Unit 1

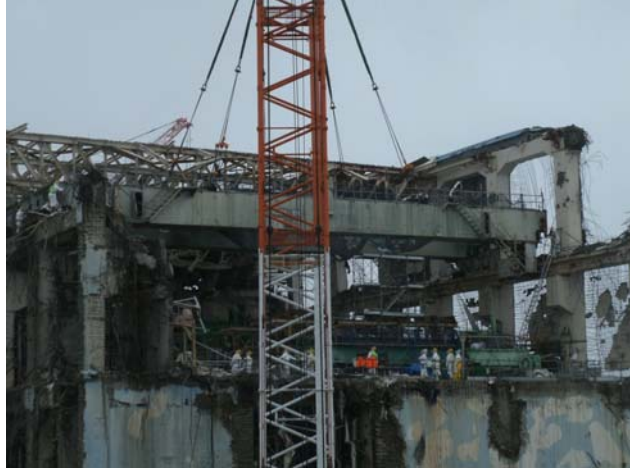
Removing rubble from Unit 4
