KAIF-JAIF Joint Forum

**Fukushima Daiichi
Decontamination and Decommissioning
: Current Status and Challenges**

May 8, 2018

Tokyo Electric Power Company Holdings, Inc.

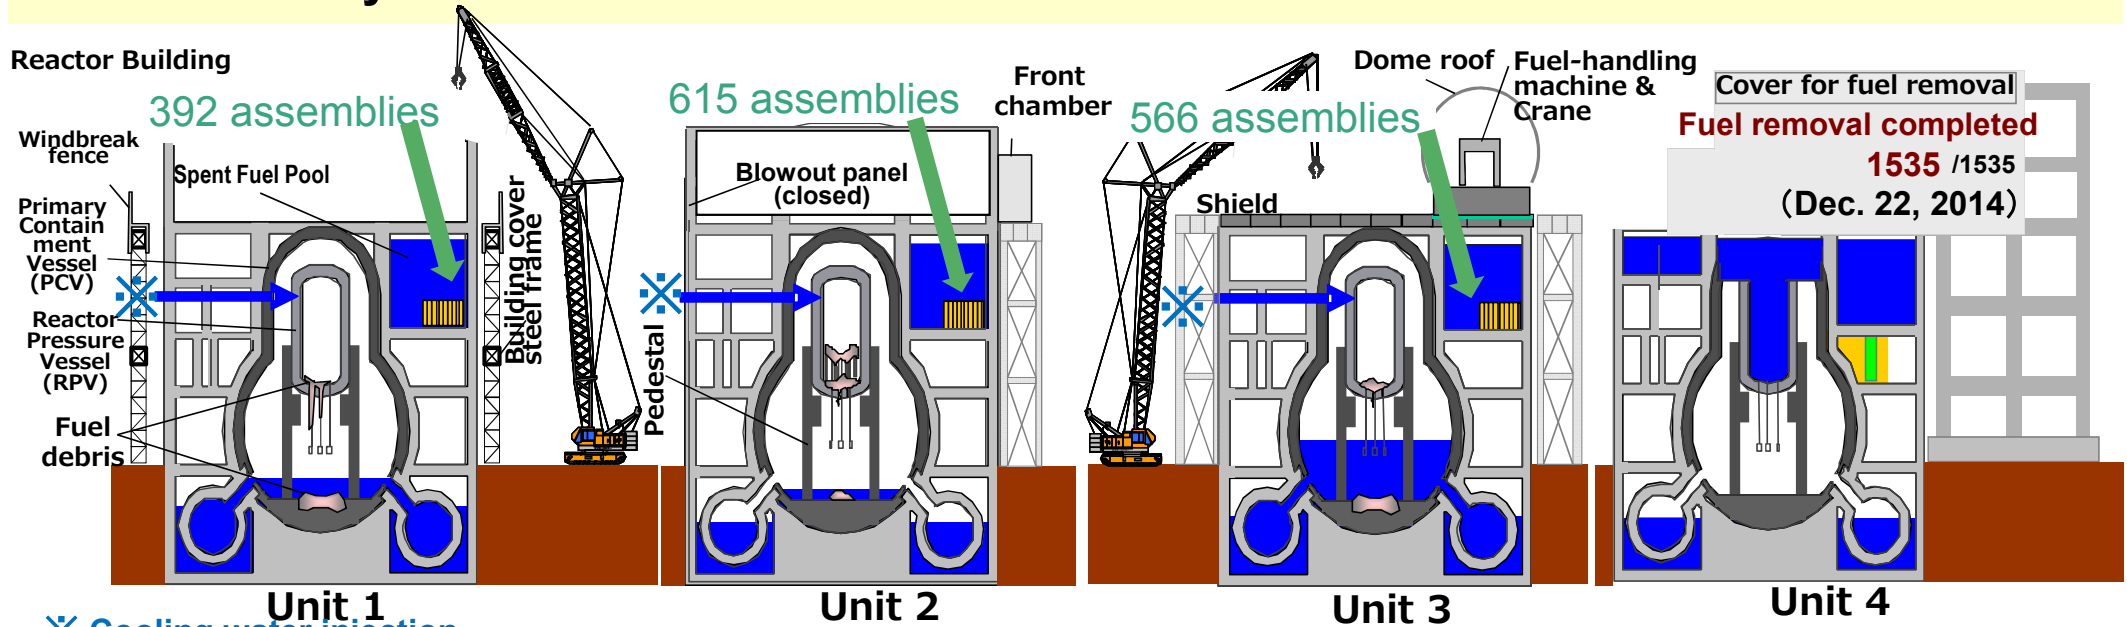
- All reactors are in cold shutdown condition.
- Plant parameters including RPV and PCV temperatures are monitored continuously 24 hours/day.

❖ Cooling water injection

Values as of 11:00 am on May 7, 2018

Temperature at the bottom of the pressure vessel	Temperature inside the containment vessel	Fuel pool temperature	Reactor coolant volume
Unit 1	18 °C	18 °C	25 °C	3. 0 m ³ /hour
Unit 2	24 °C	24 °C	26 °C	3. 0 m ³ /hour
Unit 3	22 °C	22 °C	25 °C	3. 0 m ³ /hour
Unit 4	—	—	20 °C	—

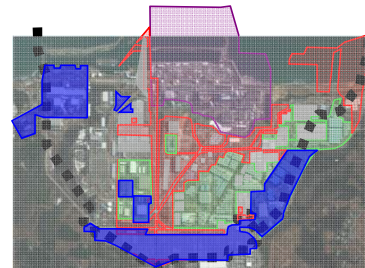
(1) Decreasing Site Radiation Dose

As a result of radiation reduction measure, workers don't have to wear full-face respirator or half-face respirator anymore in most parts of the site.

Decreasing radiation dose

: Area confirmed below 5μSv/h

FY2015 Target Achieved

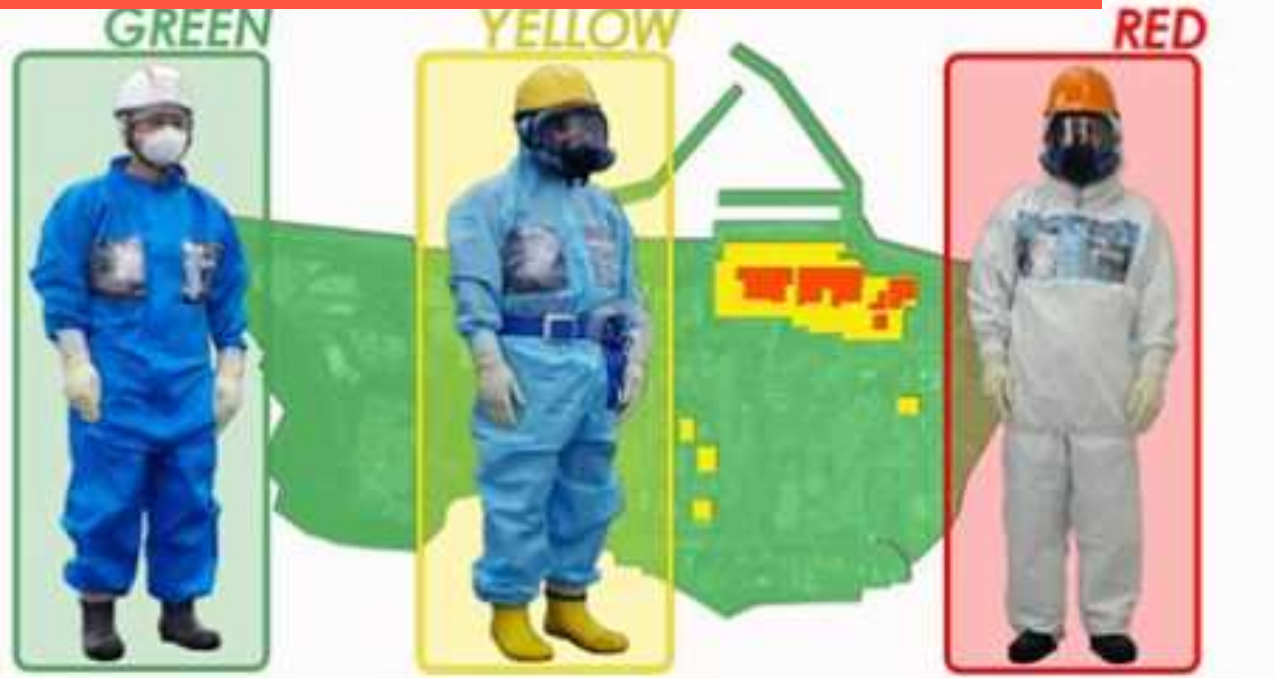
Personal equipment in each zone as of Sep. 2017

Area where people can work in general uniforms (dust mask) [95% of the site]

Area where people should work in protective gears (full-face respirator or half-face respirator)

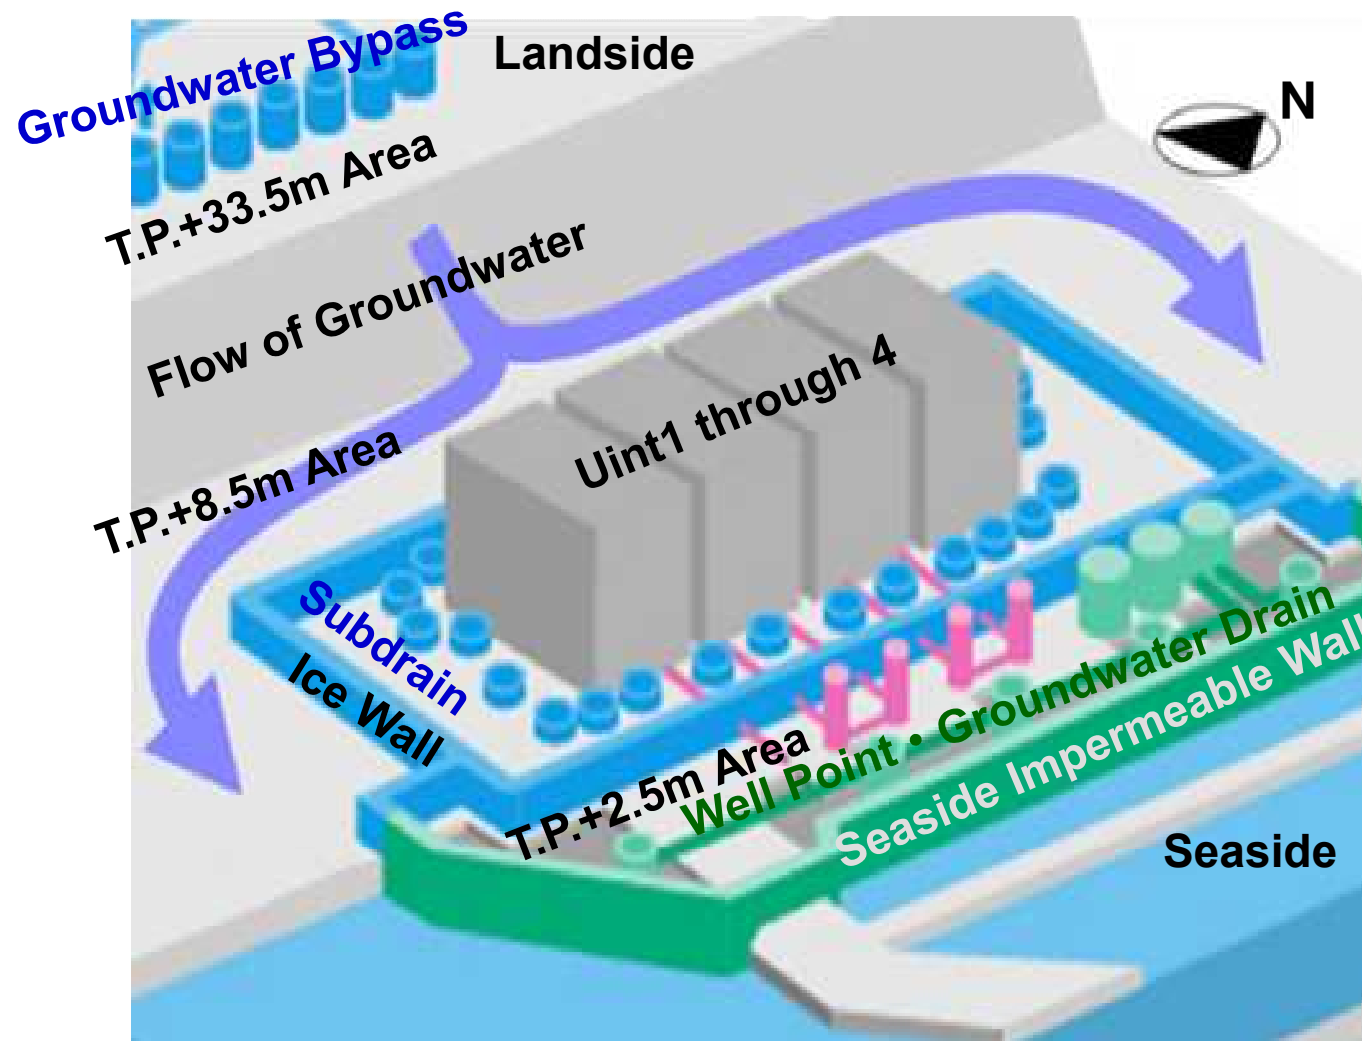
(2) Closure of the Ice Wall

- Thanks to the closure of the Ice Wall, the groundwater from the landside is dammed up and makes a detour around the buildings, and eventually flows to the seaside.

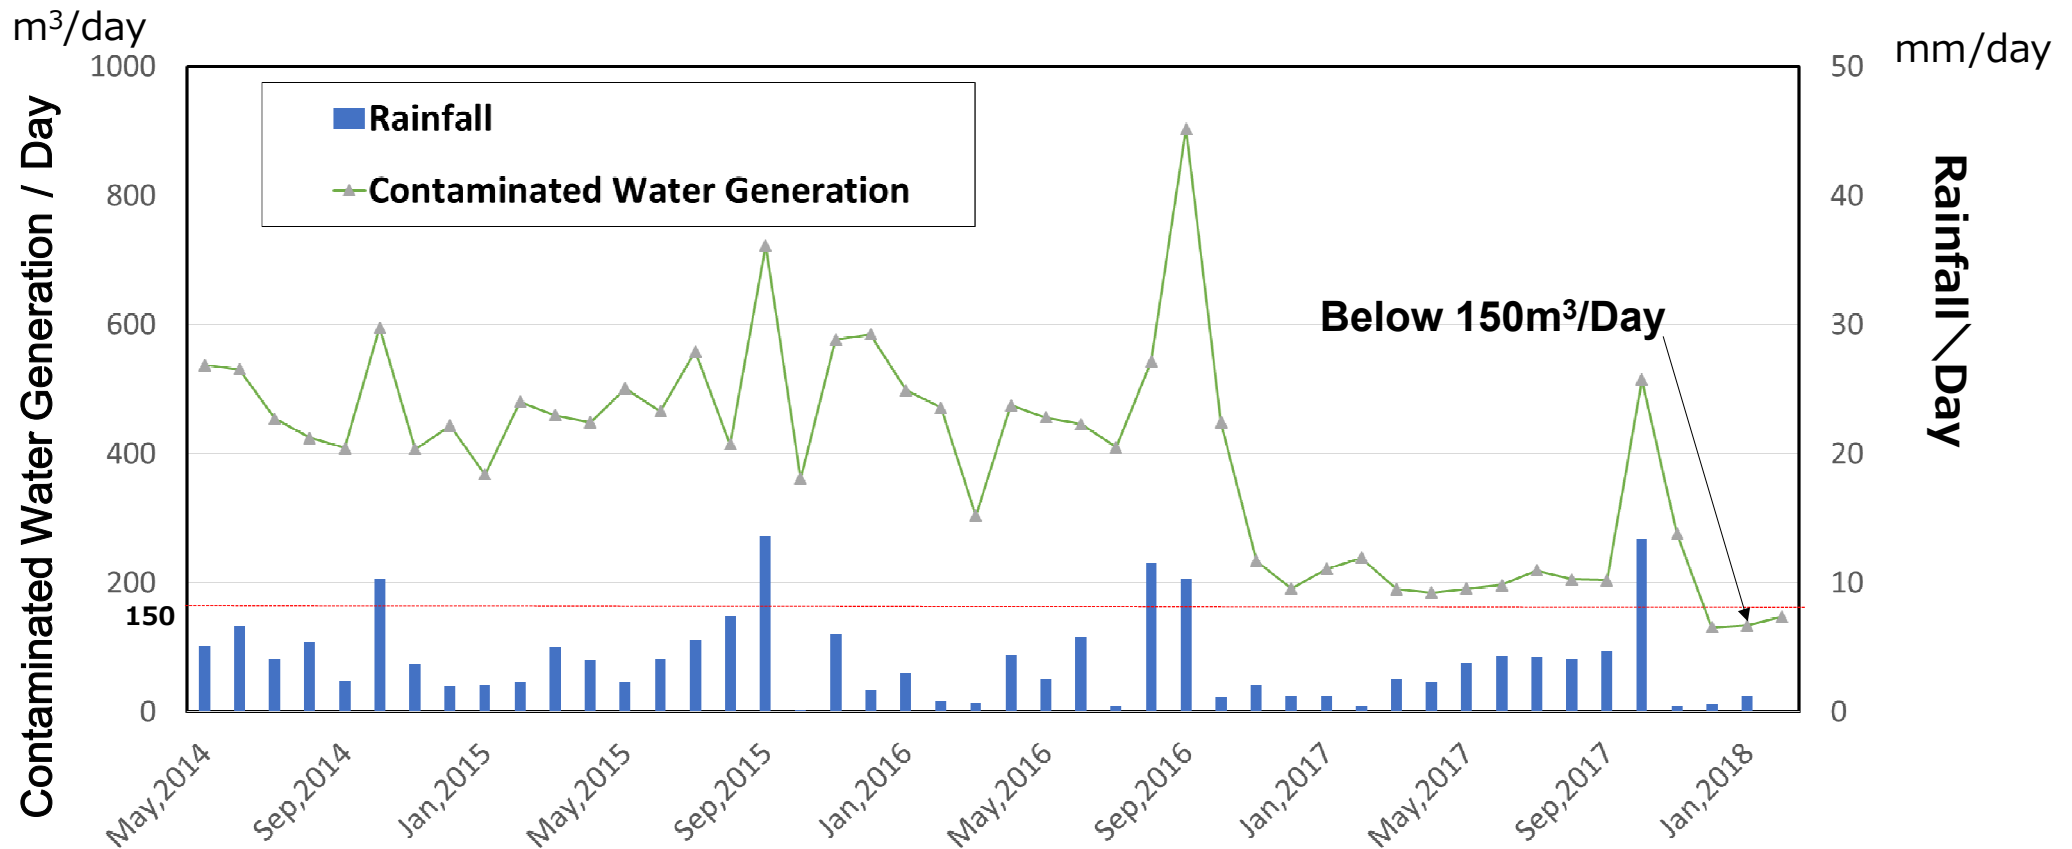
- Generation of the contaminated water originated from rainy and ground water decreased from 490m³/Day(Dec. 2015 to Feb. 2016) to 110m³/Day (Dec. 2017 to Feb. 2018) after the closure, which is about one-fourth of the initial amount.
- Generation of the contaminated water totaled 140m³/Day(Dec. 2017 to Feb. 2018) if water originated from decommissioning work was included. Even though the record was during the drought season, that amount is below the target value of 150 m³/Day set for 2020 in the Mid- and Long-term Roadmap.

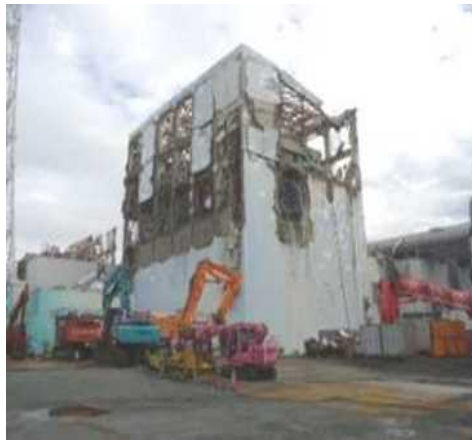
September 22, 2011

- Fuel removal started on November 18, 2013.
- Removal of 1535 fuel bundles completed on December 22, 2014 as scheduled.
- This gives confidence to proceed to fuel removal at units 1, 2 and 3.
- No risk from fuel remains at unit 4.

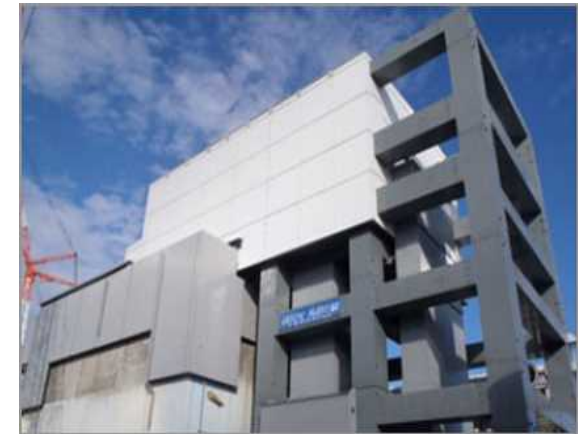
November 12, 2013: Completion of fuel removal facility (The volume of steel used is equivalent to those of Tokyo Tower)

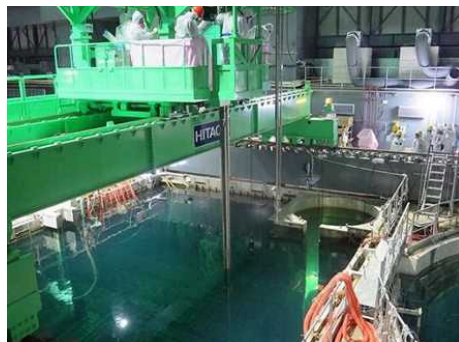
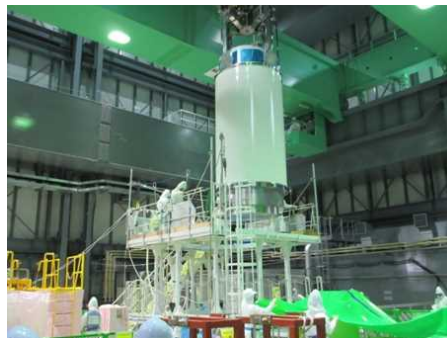
Process of removing fuel rods at SFP Unit 4

- Removal of large pieces of rubble was completed in 2015.
- Decontamination work was completed in Jun. 2016 and shielding was completed in Dec. 2016.
- Installation of a dome roof was completed In Feb. 2018.
- The fuel removal will take place in the middle of FY2018.

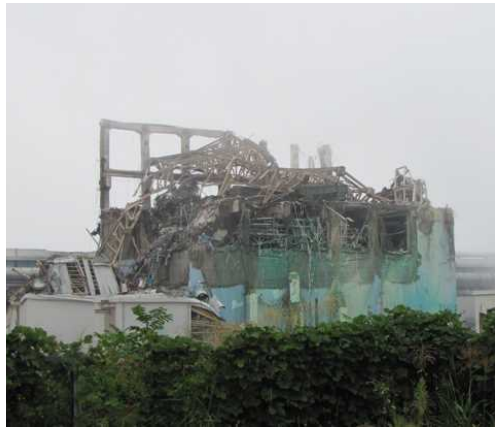
Sep..2011

Immediately after the earthquake

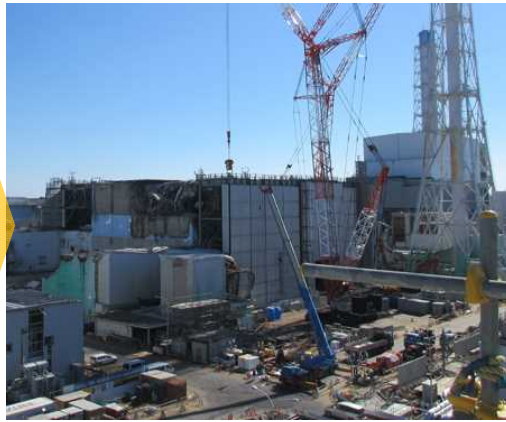
Feb. 2016

After removal of large pieces of rubble

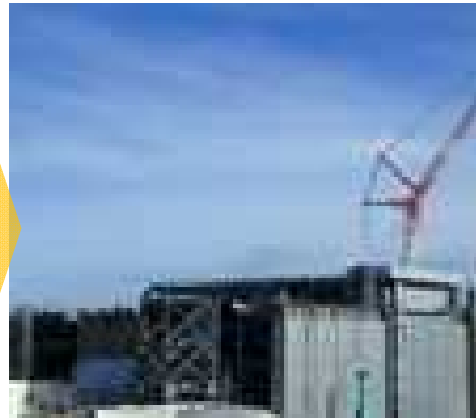
May. 2017

Installation of a basis

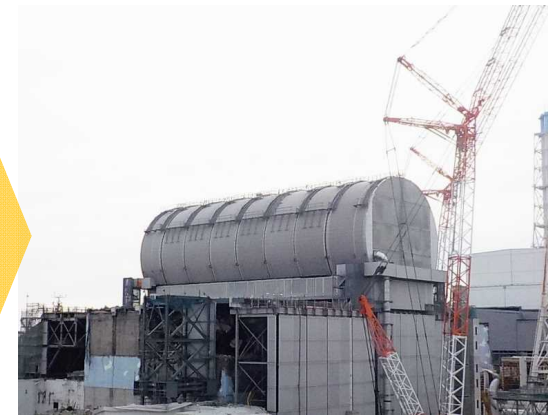
Feb. 2018

Installation of a dome roof

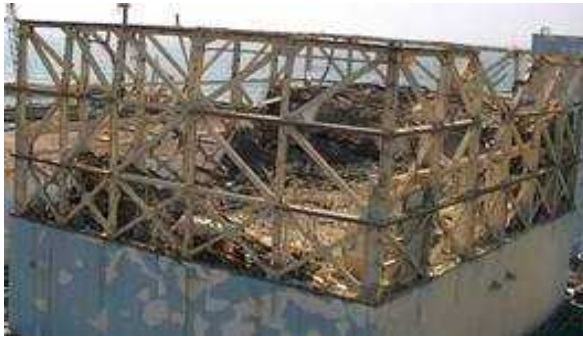
The status in 2011

- Building cover was installed in Oct. 2011 to prevent dispersion of radioactive materials.
- Removal of panels was completed in Nov. 2016. After the installation of a windbreak fence, removal of rubble started in Jan. 2018.
- Fuel removal will start in FY 2023.

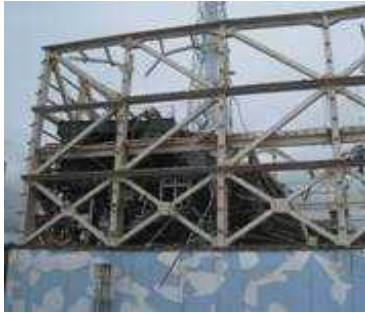
Northwest side
(Jun. 2011)

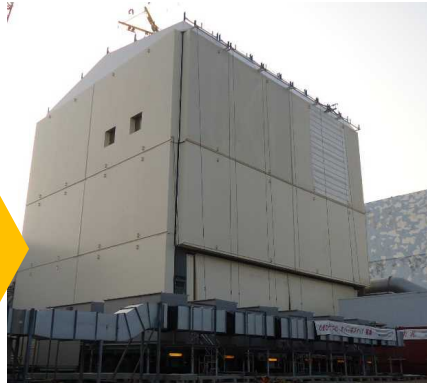
Southeast Side
(Jun. 2011)

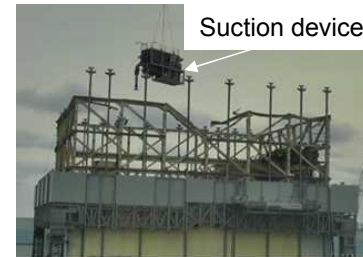
Removal of rubble
(as of Jan. 2018)

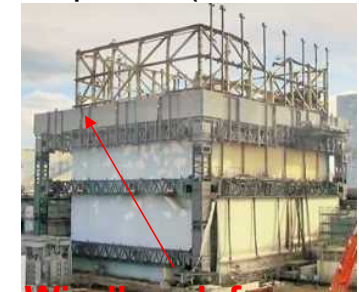
Installation of
windbreak fence
completed (Dec. 2017)

Windbreak fence

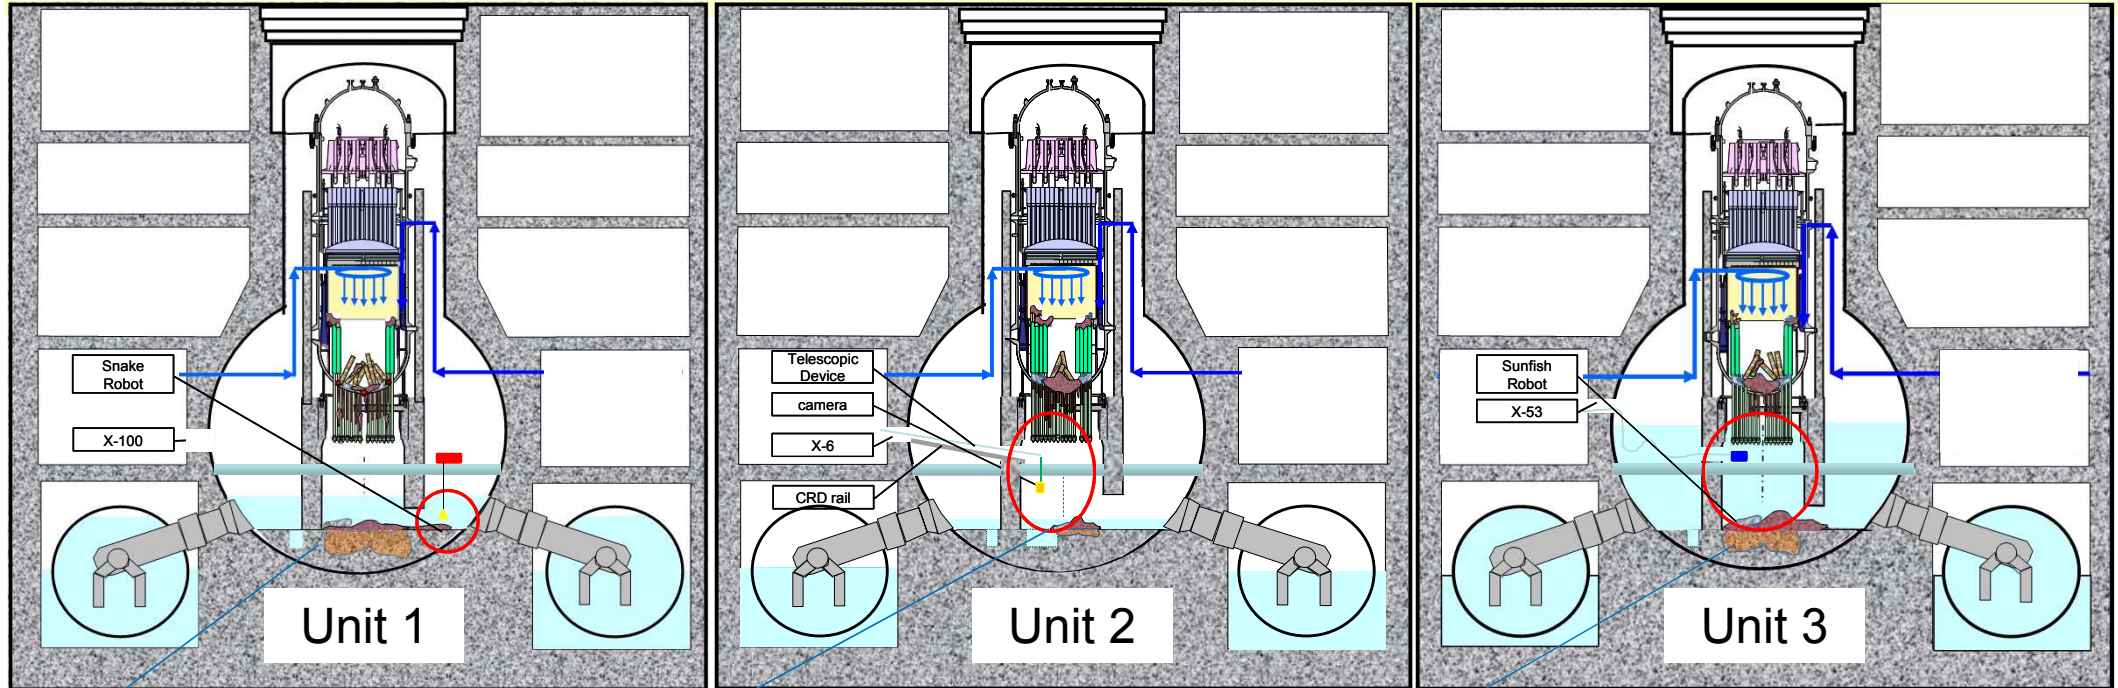
(1) Assumed Distribution of Fuel Debris

- It is assumed that at Unit 1 and 3, most of fuel debris has dropped to the bottom of PCV.
- It is assumed that at Unit 2, most of fuel debris has remained at the bottom of RPV, while only a small amount has dropped to the bottom of PCV.

Sediments were found at the bottom.

Deposits thought to be including fuel debris and fuel assembly components were identified at the bottom.

Sediments thought to be solidified molten materials and grating etc. were identified at the bottom.

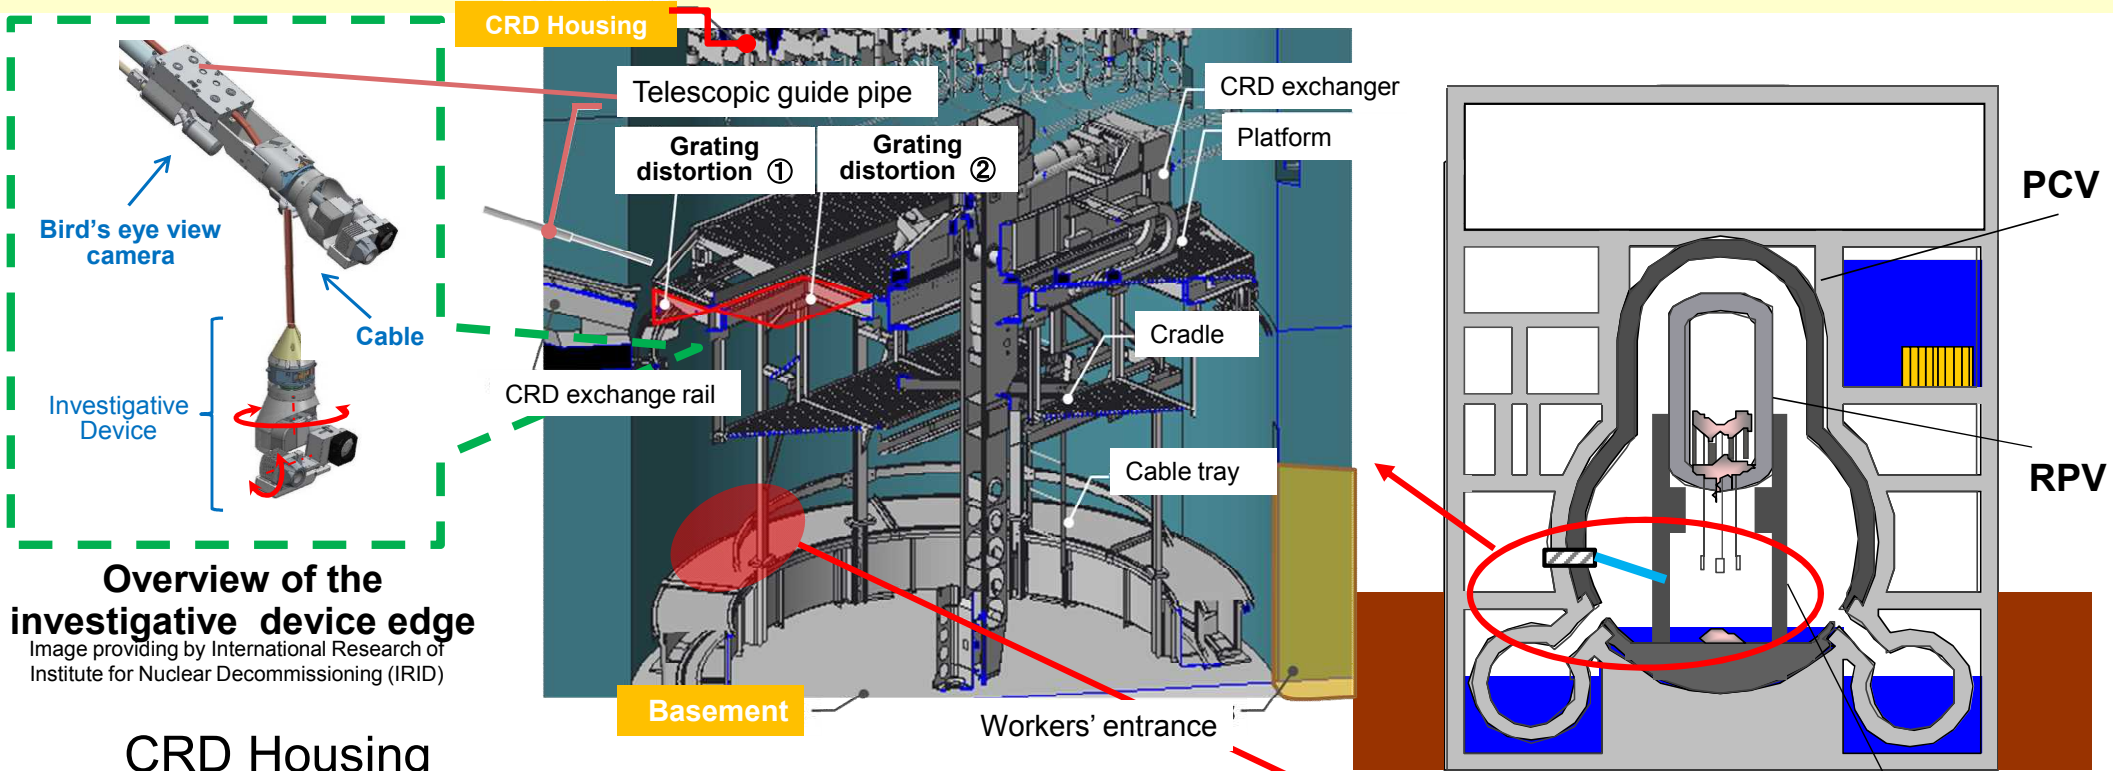
- An investigative device was lowered through distortion of the grating to the bottom of PCV inside the pedestal.
- Deposits thought to be including fuel debris as well as fuel assembly components which were located in RPV before the accident were identified at the bottom.

Overview of the investigative device edge
Image providing by International Research of Institute for Nuclear Decommissioning (IRID)

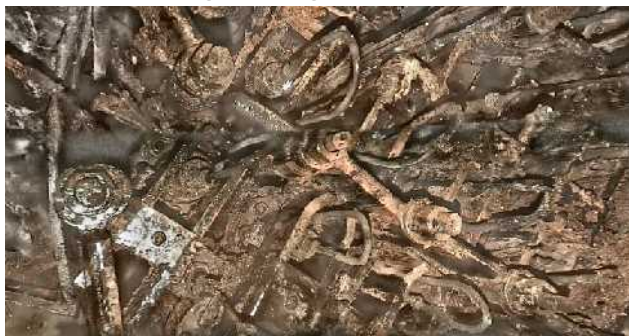
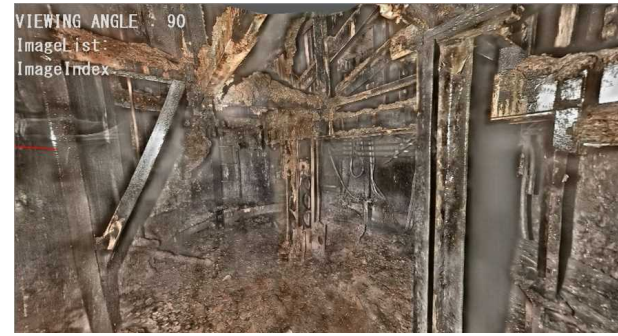
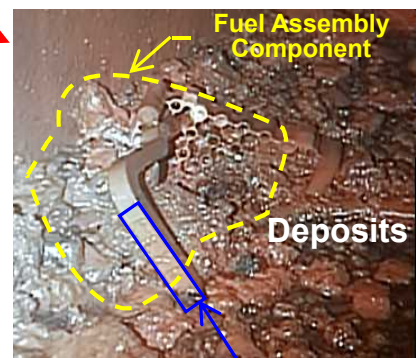
CRD Housing (above the grating distortion)

- Several fallen obstacles and sediments, such as solidified molten materials and grating were identified inside the pedestal.
- Analysis of image data shows, in contrast to Unit 2, a larger amount of fuel debris dropped inside the pedestal.

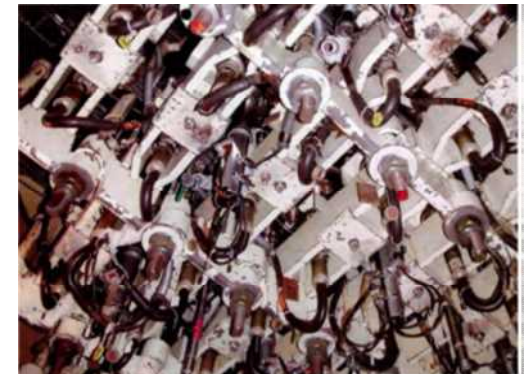
<Ref. >
CRD housing support of Unit 3 before 311 accident

Damage to multiple structures around CRD housing was found.
