Fukushima Daiichi NPS (As of September 2018)

# History of the Fukushima Daiichi since the Accident

# Conditions at the Fukushima Daiichi

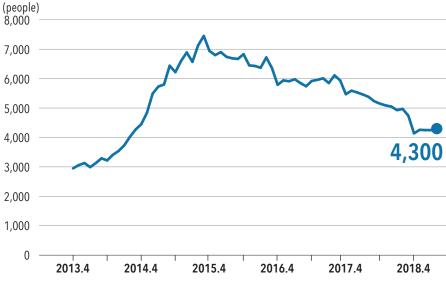
Trends in the average number of workers engaged in work on weekdays (actual tallies)

As of July 2018, approximately 4,300 workers (contractors and TEPCO employees) engage in work at the power station daily. As of June, approximately 60% of these people have been hired from within Fukushima prefecture.

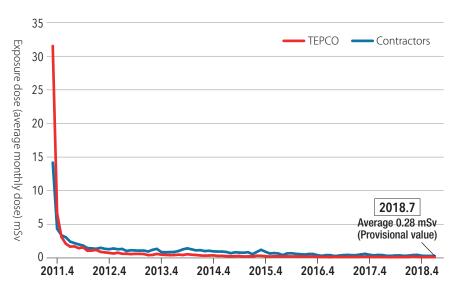
Trends in individual exposure doses per month for workers (average monthly dose)

Since FY2015, the average monthly dose of workers has remained steady at below 1mSv, and situation where the exposure doses of most workers are far below dose limits has been maintained.

(Legal dose limit: 50mSv/year or 100mSv/ 5years)

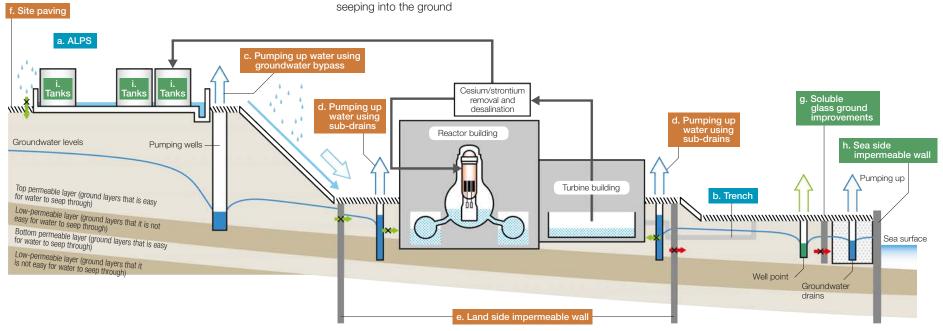
Preventative and multilayered contaminated water countermeasures have been implemented based upon the three basic policies.

- a. Purify contaminated water using ALPS, etc.
- b. Remove contaminated water from trenches (underground tunnels used for pipes, etc.)

- c. Pumping up of groundwater using the groundwater bypass
- d. Pumping up water from wells (sub-drains) around buildings
- e. Construct an impermeable wall on the land side by freezing soil
- f. Pave the sites to prevent rainwater from seeping into the ground

- g. Use soluble glass to make ground improvements
- h. Build an impermeable wall on the sea side
- i. Install additional tanks (replace tanks with welded tanks, etc.)

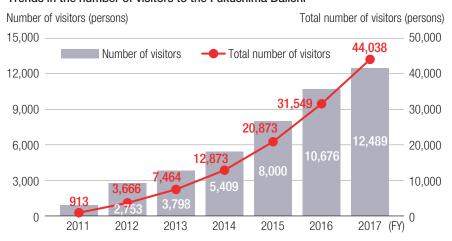
#### Trends in the number of visitors to the Fukushima Daiichi

having visitors see with their own eyes the progress at the power station. In FY2017, 12,500 people visited the site, bringing the grand total for the number of visitors to the site since FY2011 to 44,000. Approximately 10% of these visitors were from overseas. TEPCO aims to increase the number of visitors so that approximately 20,000 people are visiting annually by FY2020.
