**Japan's side event in the IAEA General Conference 2021**

# **Fukushima Daiichi Decommissioning 10 years on since the accident**

**September, 2021**

**Fukushima Daiichi Decontamination and Decommissioning Engineering Company,  
Tokyo Electric Power Company Holdings, Inc.**

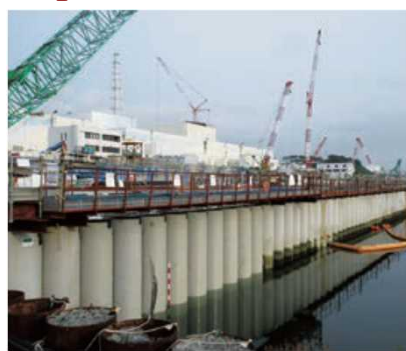
**October 2015**  
Completion of sea-side impermeable wall

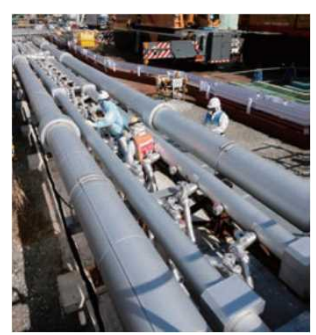
**March 2018**  
Frozen soil wall (Ice Wall) completed in most of the areas

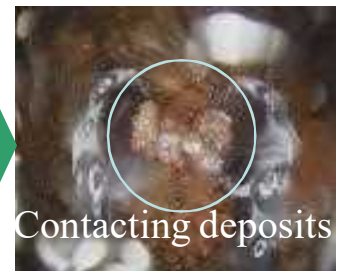
**February 2019**  
Touching investigation of deposits in Unit 2 PCV

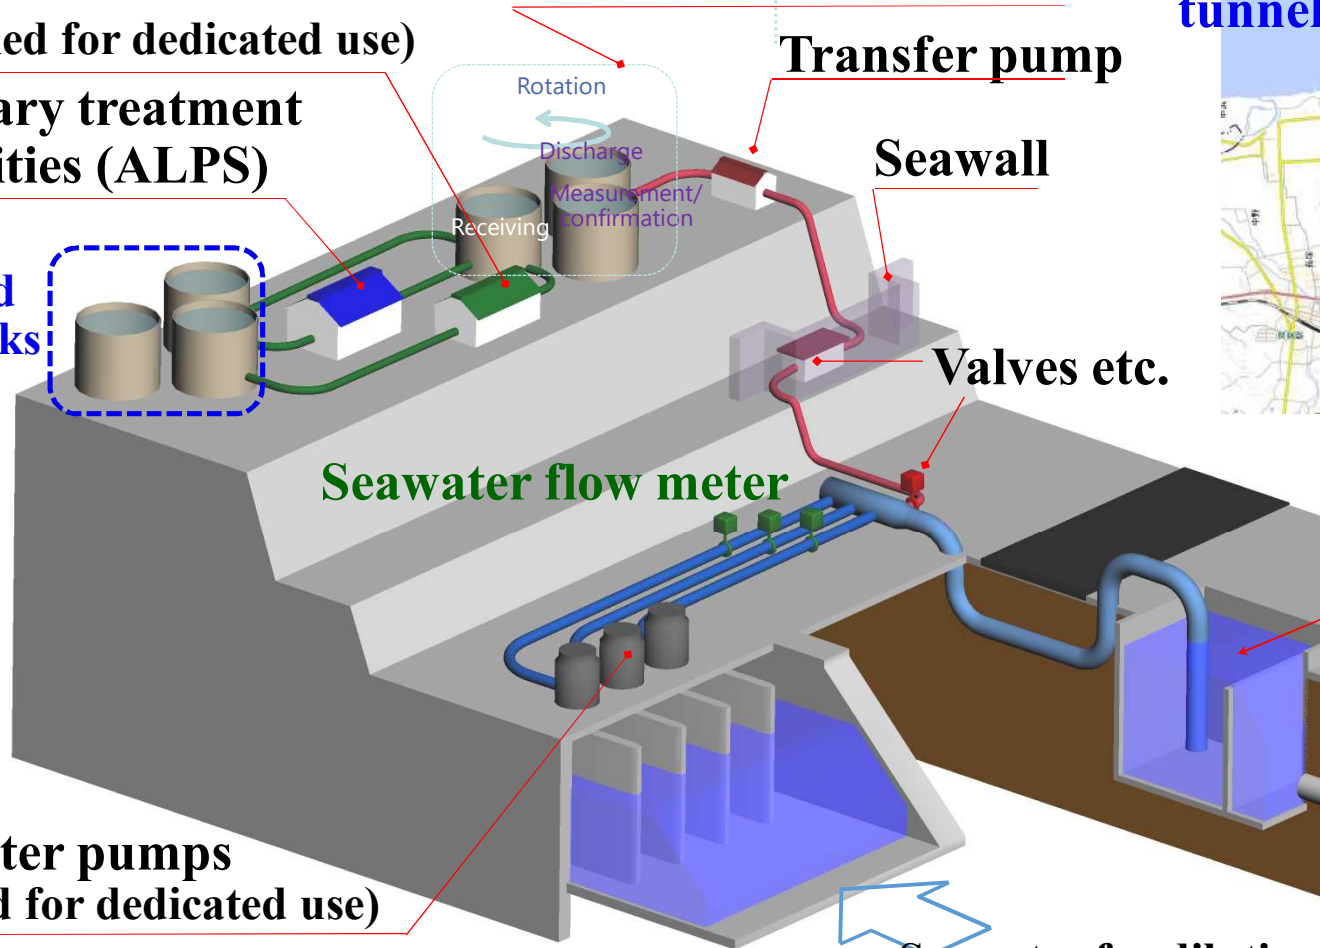
# Design and operations for ALPS treated water discharge (blueprint)

**Secondary treatment facilities**  
(reverse osmosis membrane facilities are to be installed for dedicated use)

**Secondary treatment facilities (ALPS)**

**ALPS treated water, etc. tanks**

**Measurement/confirmation facilities (K4 tank group)**

**Transfer pump**

**Seawater flow meter**

**Seawater pumps**  
(to be installed for dedicated use)

**Confirming that ALPS treated water has mixed with sea water and been diluted before discharge**

**Undersea tunnel (approx. 1km)**

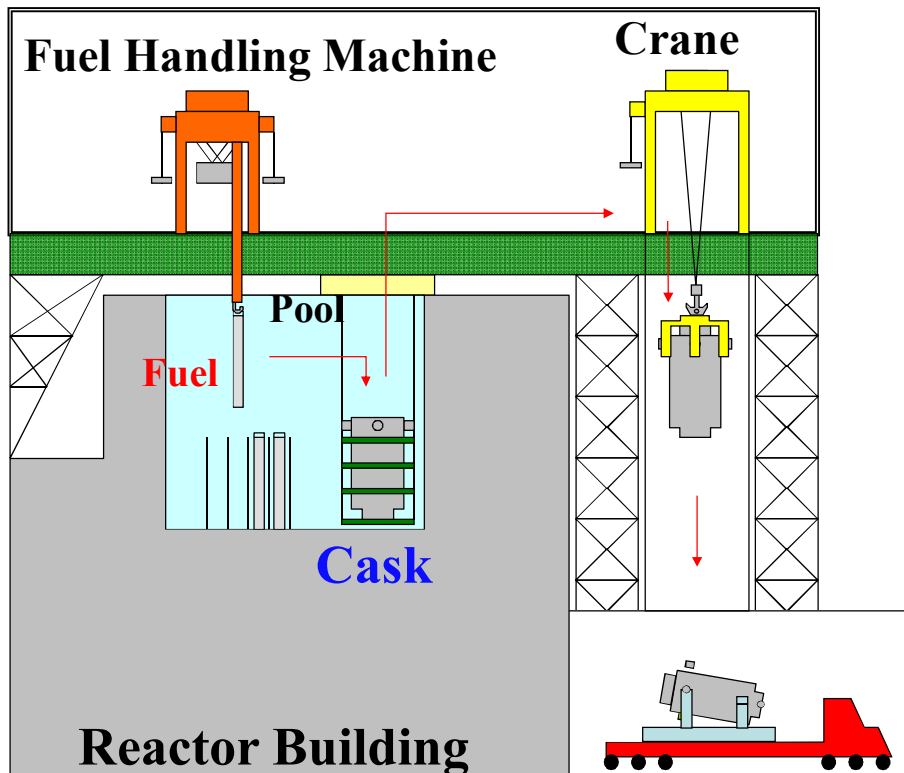
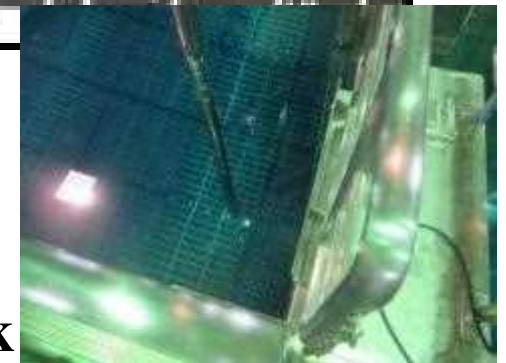
# What is spent fuel removal?

- After loading onto the fuel transfer cask, spent fuel is transported to the on-site common pool and stored in the fuel rack.

Site transfer

Store in fuel rack

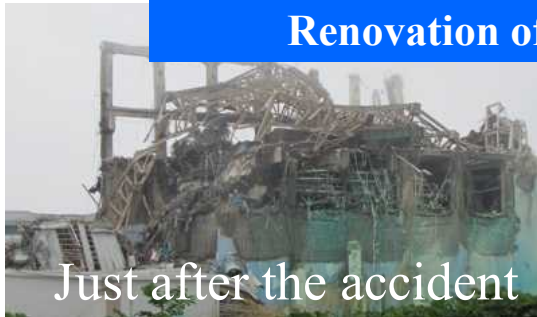
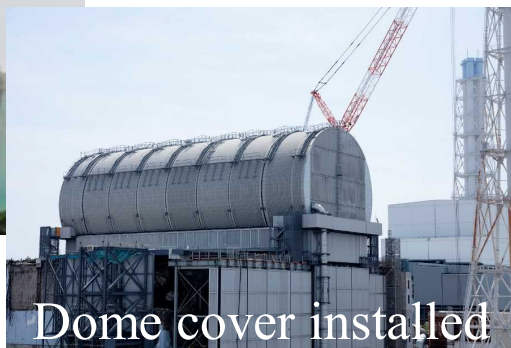
### Renovation of Unit 3

- Since the upper part of the building was highly radioactive, most work including rubble removal and fuel removal was carried out via remote operation.
- Lessons and knowledge obtained from the work will be used in the removal at Units 1 & 2 and other projects.

- Removal of rubble on the refueling floor
- Removal of rubble in the spent fuel pool
- Decontamination on the refueling floor
- Shielding on the refueling floor

- Fuel handling machine
- Dome cover

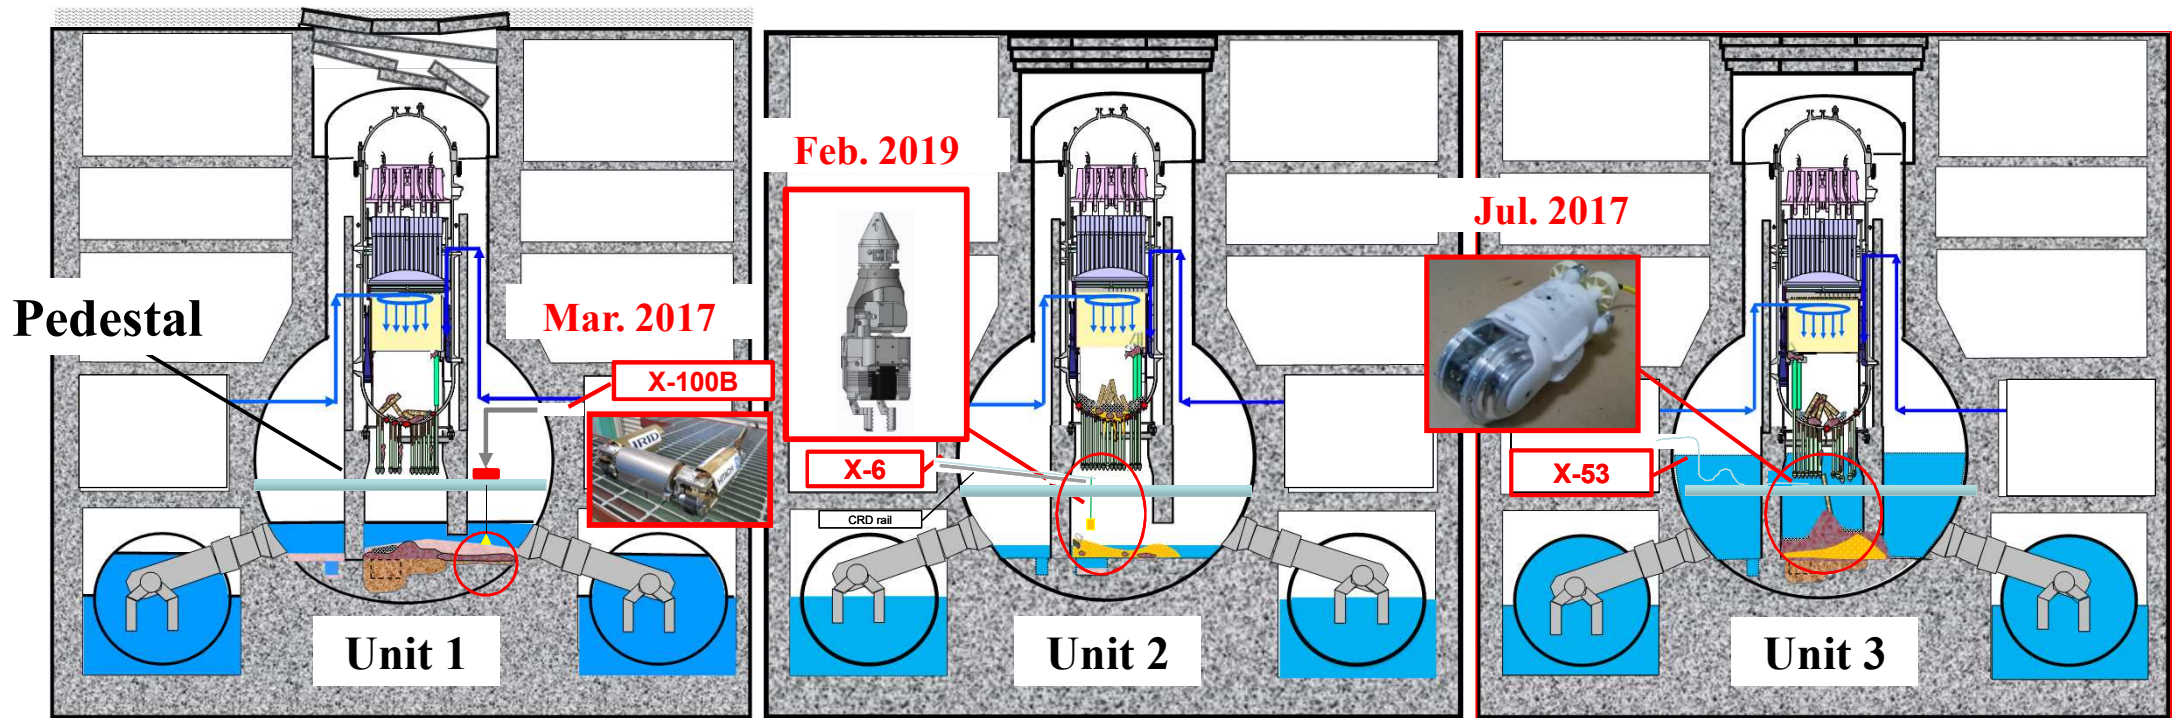
# Assumed distribution of fuel debris

Robotic exploration

Analysis of accident transient

Muon Survey

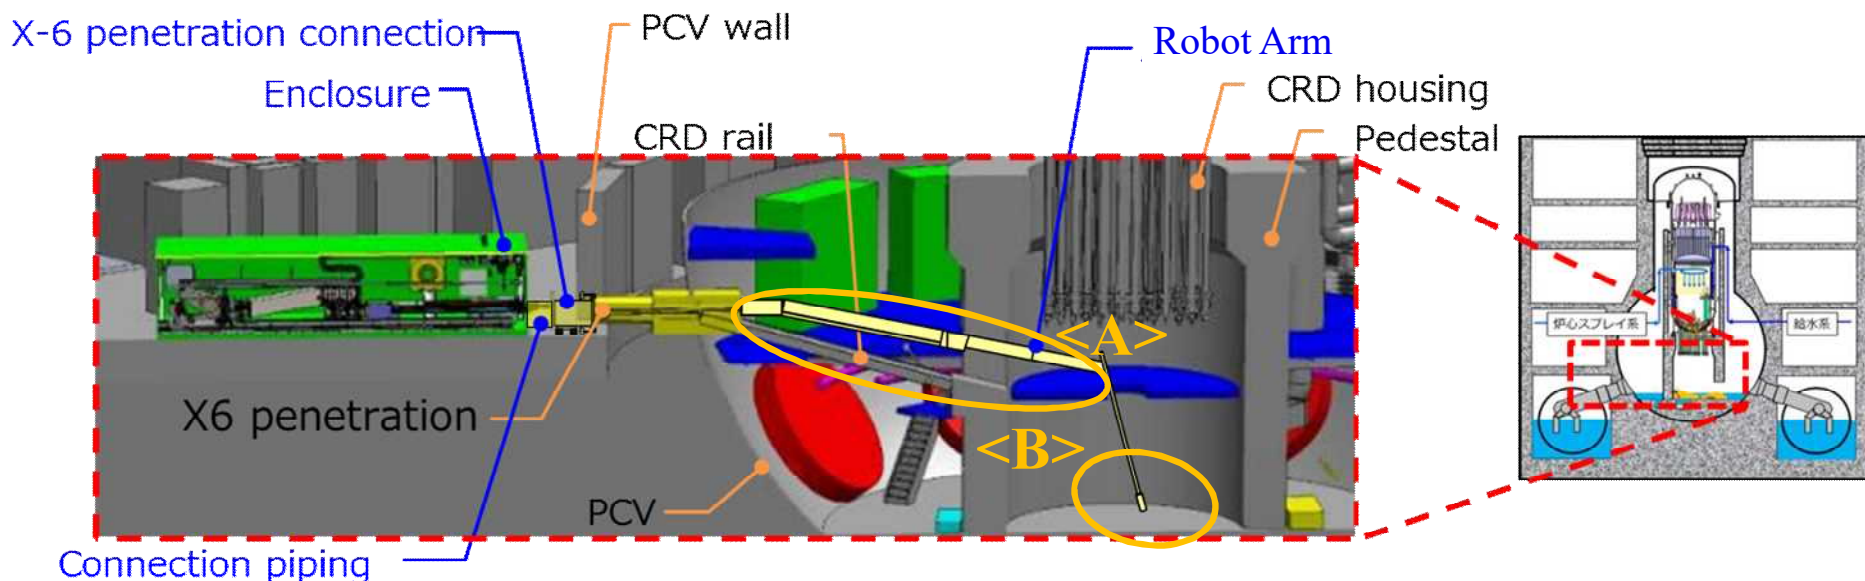
# Equipment to be used for fuel debris retrieval at Unit 2

- The first trial retrieval to be rescheduled for FY2022 due to the coronavirus in the U.K.
- Stepwise expansion of the retrieval scale to follow after the first trial.

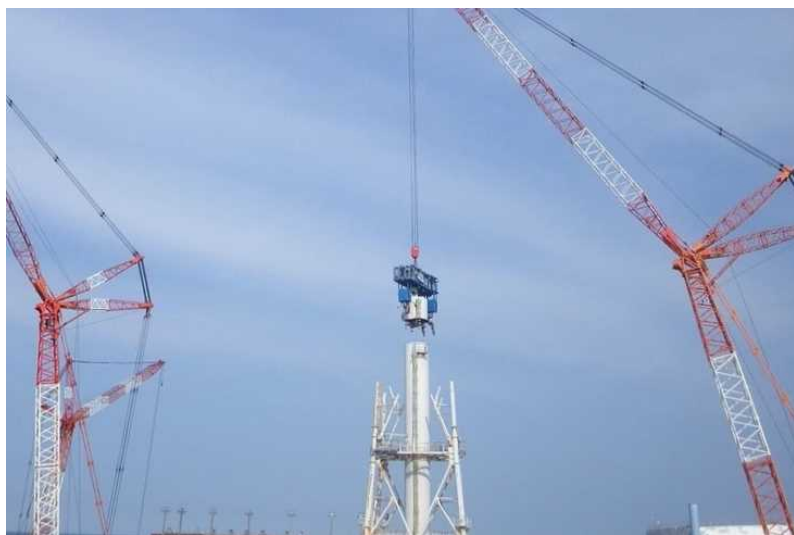
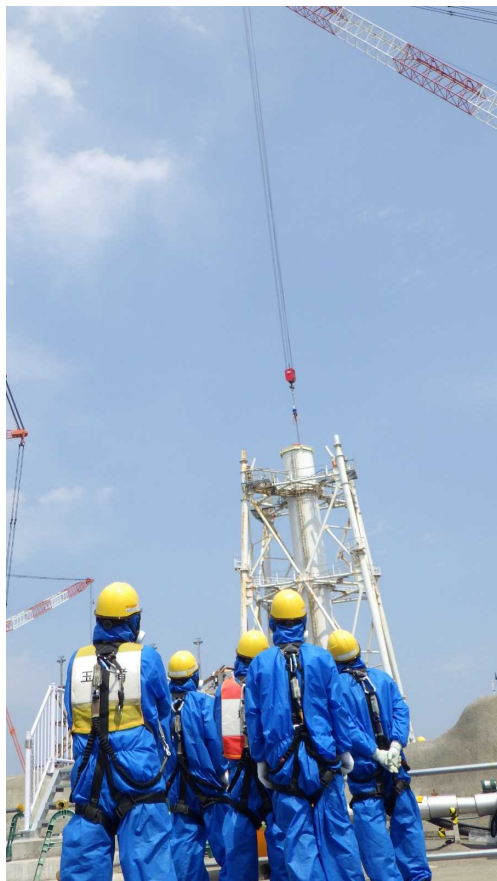
## Dismantlement of the exhaustive stack for Units 1 & 2 ( by a local firm )

- A firm based in Fukushima accomplished dismantlement of the exhaustive stack for Units 1 & 2.
- We held briefing sessions for local businesses as well as meetings between local firms and TEPCO's contractors.
