# **Current Status and the Future of Fukushima Daiichi Nuclear Power Station**

April 13, 2015

Chief Decommissioning Officer,  
President of Fukushima Daiichi Decontamination and  
Decommissioning Engineering Company,  
Tokyo Electric Power Company

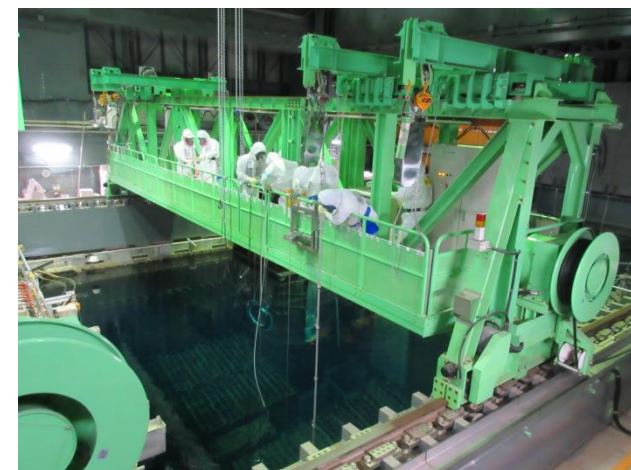
- The fuel assemblies (1533 rods) stored inside the Unit 4 spent fuel pool were transferred to the common pool.
  - External wall for removing fuel rack was built (4,000 tons of steel used, construction period : March 2012 to May 2013)
  - The transfer started on 18 November 2013 and completed on 22 December 2014.
- ① Relocate the fuel assemblies stored in the fuel rack inside the spent fuel pool, one by one, into a transportation container (cask) underwater using a fuel handling machine.
  - ② Lift up the cask from the spent fuel pool using a crane.
  - ③ Conduct, on the floor as high as the operating floor, such works as closing the lid of the cask and decontaminating the cask.
  - ④ Lift down the cask toward the ground using the crane to lay it on a trailer.
  - ⑤ Transport the cask to the common pool using the trailer.

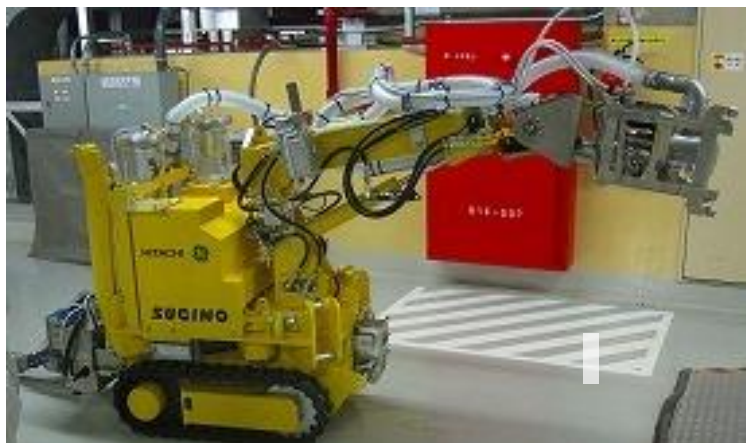
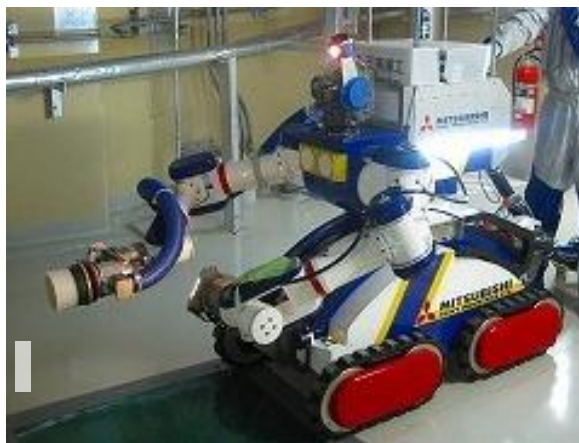
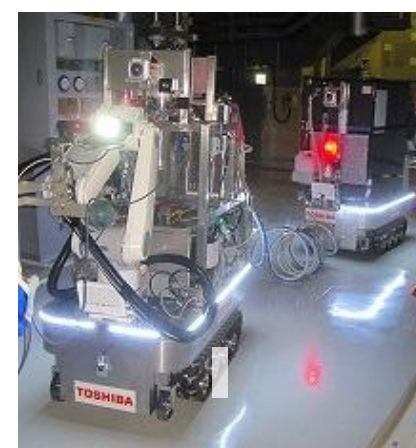
### Decontamination robot

As the inside of reactor buildings are highly contaminated, robots for decontamination were developed. (Following photos are robots for lower level)

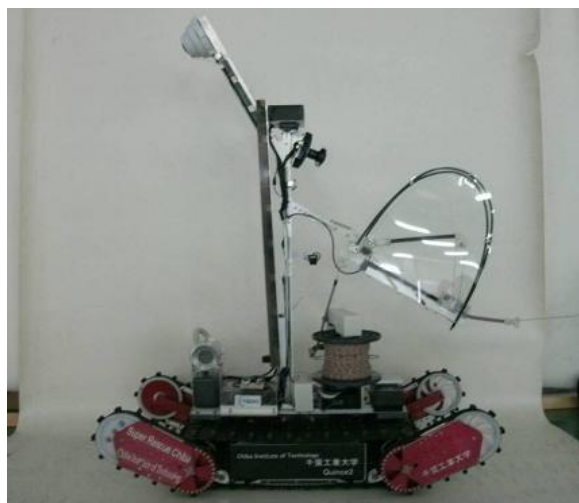
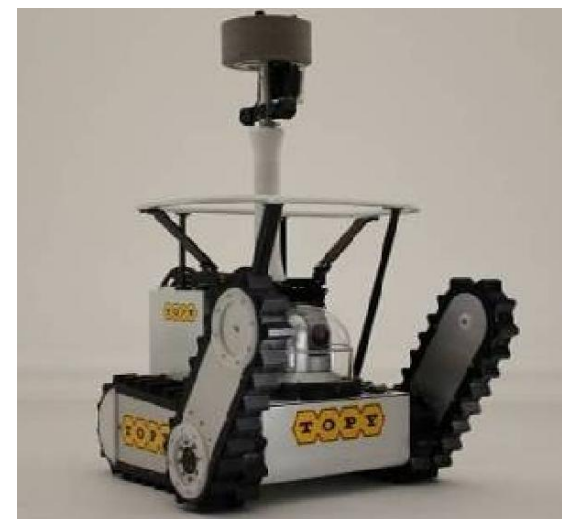
### Research robot

In order to measure radiation dose and take photos inside buildings, robots with camera which can move on debris were developed.

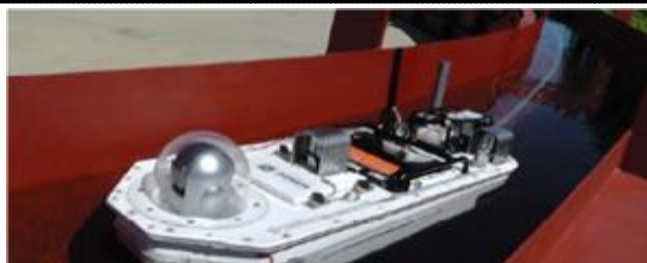
Water boat

- To repair (seal the water leak locations of) the PCV in preparation for the fuel debris removal, investigation under vent pipes was conducted to identify the leak locations in the PCV.
- With the images taken by the camera equipped with the water boat, it was checked whether there is any water flow from the sleeve ends of vent pipes or not, and the status of the sand cushion drain pipes was also checked (by viewing appearance).

Water boat: trial operation at the plant
