The 49<sup>th</sup> JAIF Annual Conference

# Current Status and Future of The Fukushima Daiichi Nuclear Power Station

Akio KOMORI

Tokyo Electric Power Company Holdings, Inc.

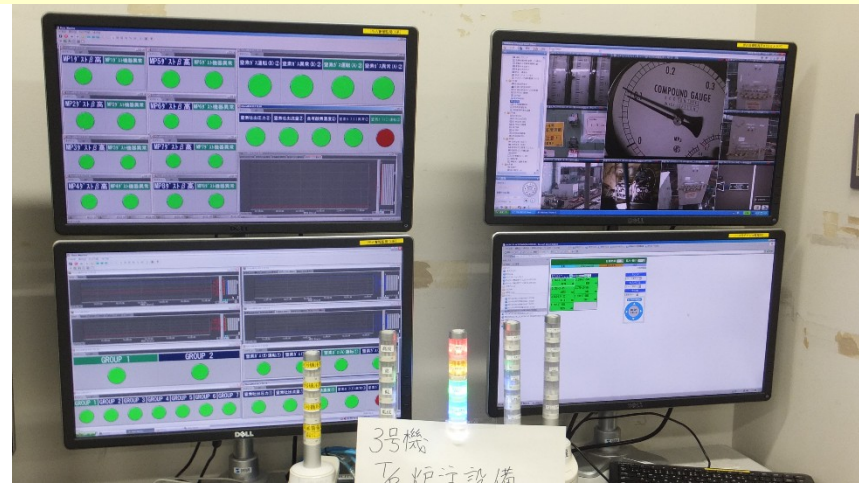
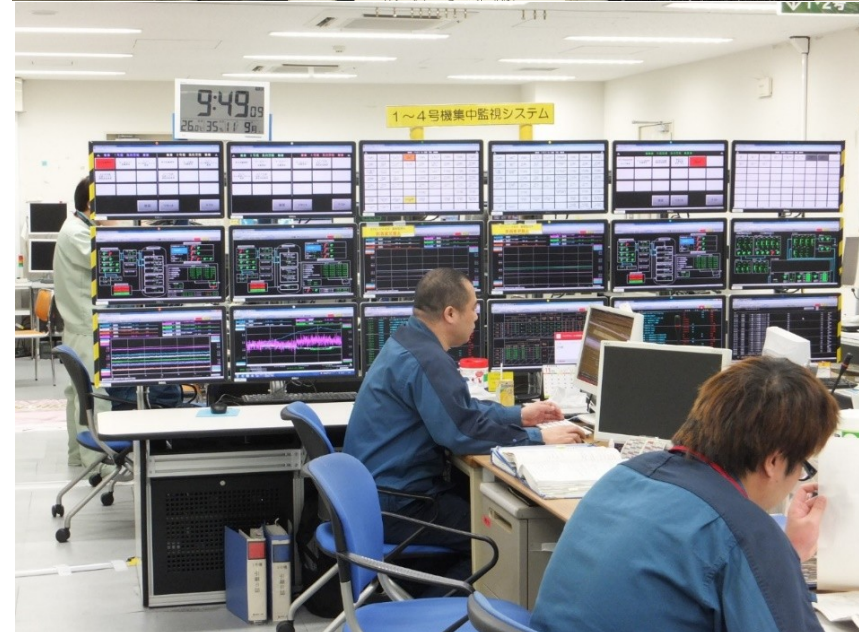
■ Plant condition is monitored in TSC control room

In order to enhance safety level, multiple water injection systems are installed.

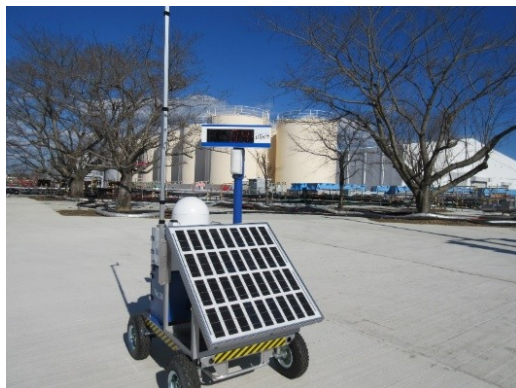
Monitor of dose rate

- The system of visualizing the real time dose data is in place by deploying 86 dose rate monitors on site.
- The display of data monitors should be placed at the point where workers can be easily accessible. Continuous dust monitoring data is also shown on the display.

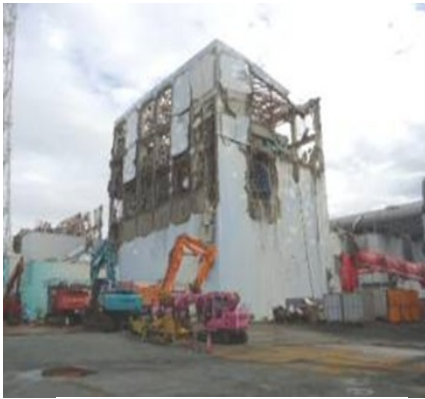
September 22, 2011

- Fuel removal from the spent fuel pool started on November 18, 2013
- Removal of 1535 fuel bundles completed on December 22, 2014 as scheduled
- No risks from fuel remains at unit 4. This gives confidence to proceed to fuel removal at units 1, 2 and 3

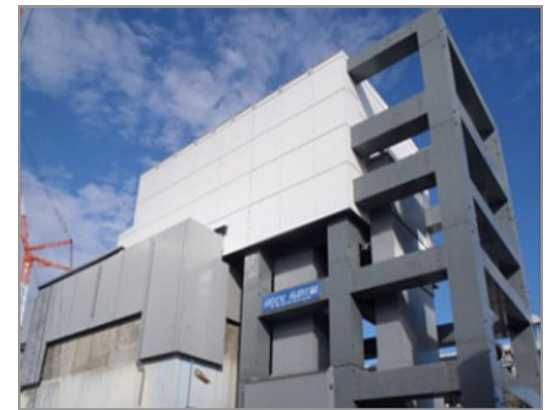
November 12, 2013: Completion of building steel framework (The volume of steel used is equivalent to those of Tokyo Tower.)

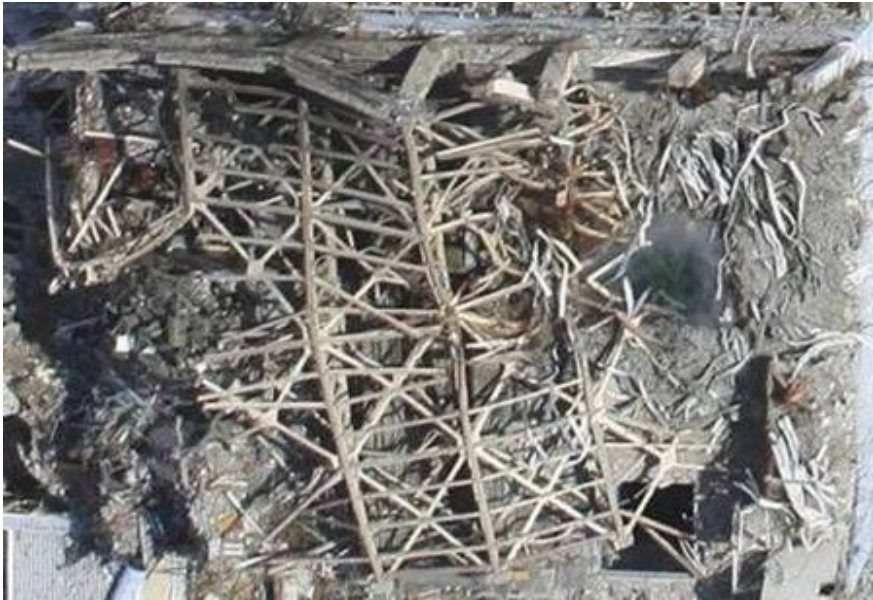
### Before removing large rubble

Photo taken in March 2011

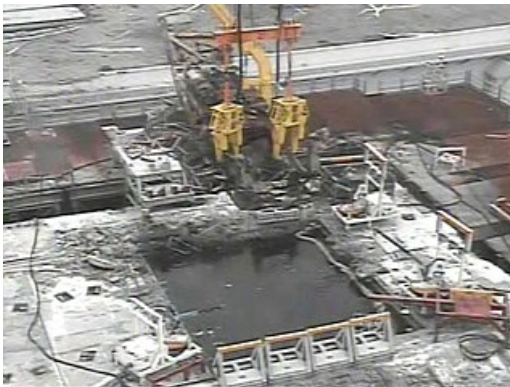
**Removal of Fuel Handling Machine from SFP (Aug. 2015)**

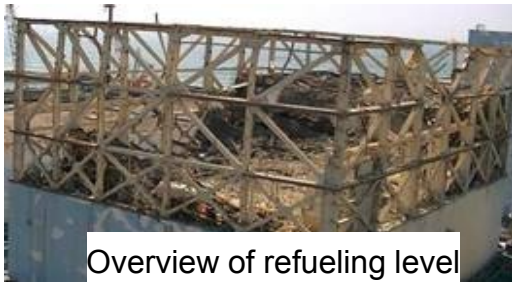
- Many rubbles were scattering on the refueling floor untouched inside the reactor building cover which was installed soon after the accident in 2011
- Current and future work: with measures against dust dispersion
- ✓ Building cover removal in progress
- ✓ Removal of rubble
- ✓ Decontamination and shielding work for dose reduction
- ✓ Installation of deck and fuel handling equipment for fuel removal

Overview of refueling level  
Photo taken in June 2012

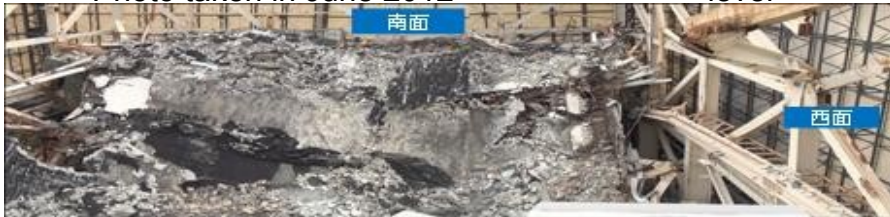
Conditions of the top of operating

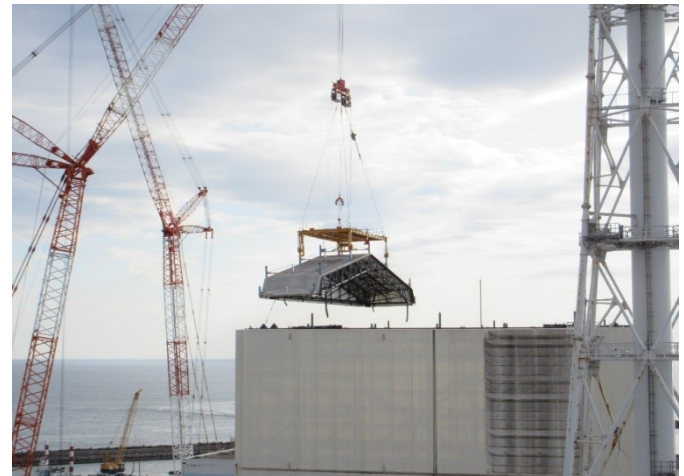
Reactor building cover

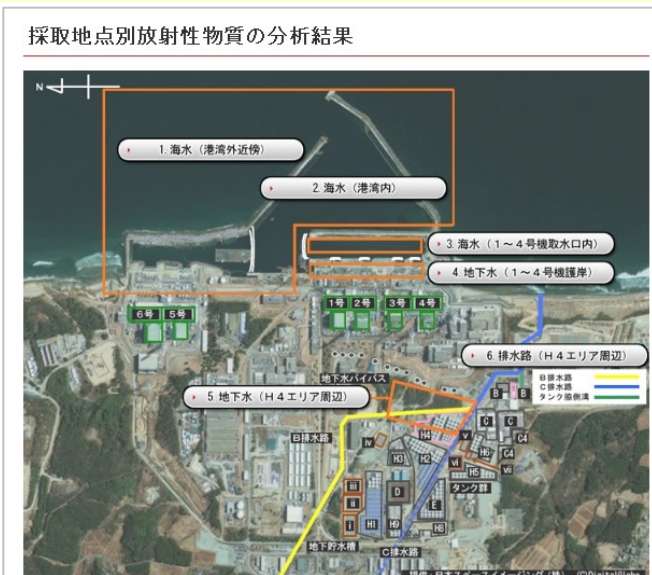
<Results for radiation dose>

- In accordance with agreements, TEPCO reports to local governments about the progress of decommission tasks. TEPCO also informs them of any accidents and troubles at Fukushima site.
- TEPCO reviewed how to report the results of data analysis so that the latest data of radioactive dose can be easily accessible.
- More visualized information and video footage is available to enhance the understanding of decommission work.
- The layout of website ( <http://www.tepco.co.jp/nu/fukushima-np/index-j.html> ) is reviewed to make search of specific topics easily.
