Current Status and the Future of Fukushima Daiichi Nuclear Power Station

April, 30 2015

Fukushima Daiichi Decontamination and
Decommissioning Engineering Company,
Tokyo Electric Power Company

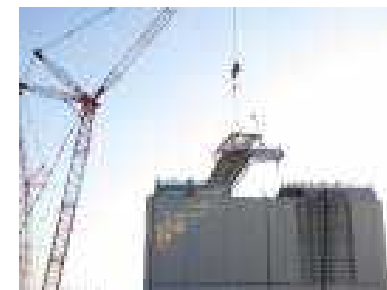
Building cover installed on reactor building (November 2011)
Removal of the building cover temporarily to see the condition of rubble accumulation (October to December 2014)

Photo taken on 10 Oct 2014: Removing cover

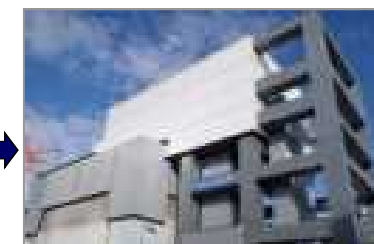
Fuel removal from SFP completed (on December 22, 2014)

Photo taken on 12 Nov 2013

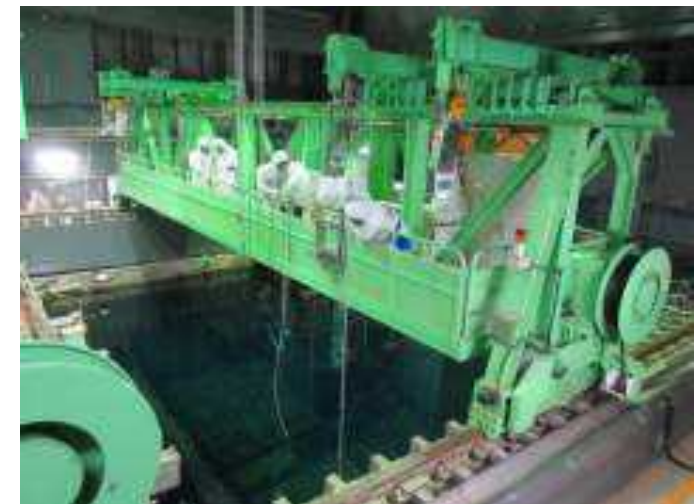
- The fuel assemblies (1533 rods) stored inside the Unit 4 spent fuel pool were transferred to the common pool.
 - External wall for removing fuel rack was built (4,000 tons of steel used, construction period : March 2012 to May 2013)
 - The transfer started on 18 November 2013 and completed on 22 December 2014.
- ① Relocate the fuel assemblies stored in the fuel rack inside the spent fuel pool, one by one, into a transportation container (cask) underwater using a fuel handling machine.
 - ② Lift up the cask from the spent fuel pool using a crane.
 - ③ Conduct, on the floor as high as the operating floor, such works as closing the lid of the cask and decontaminating the cask.
 - ④ Lift down the cask toward the ground using the crane to lay it on a trailer.
 - ⑤ Transport the cask to the common pool using the trailer.

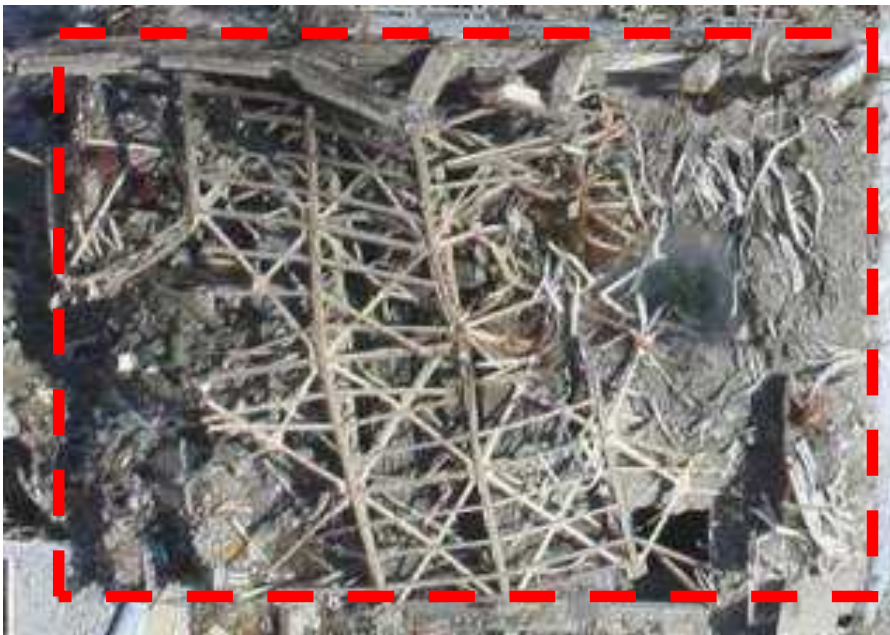
Before removing large rubble

Photo taken in March 2011

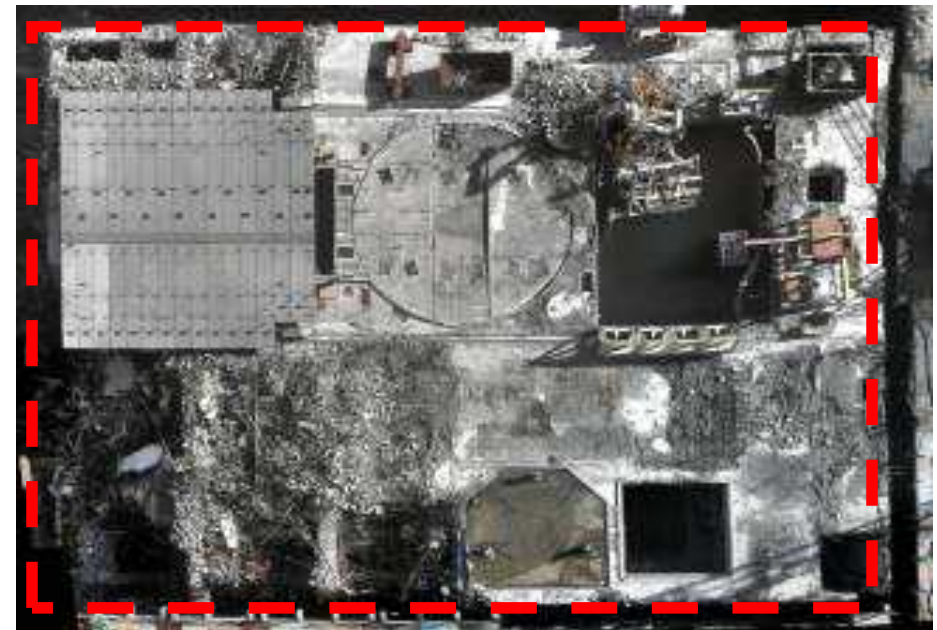
Current status (decontamination work in progress)

Photo taken in December 2014

- Removal of rubble has been completed and decontamination and shielding work is underway
→ Anti-scattering measures are taken during decontamination work as used in removing rubble.
- Removing rubble in SFP is in progress
→ As debris are in the pool, no anti-scattering measures taken for this task.

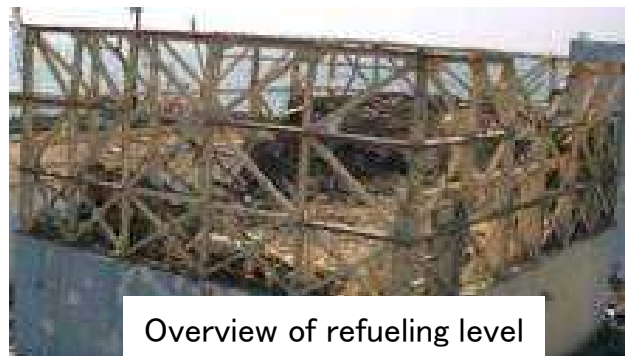
Conditions on the top of operating floor of R/B

Overview of refueling level
Photo taken in June 2012

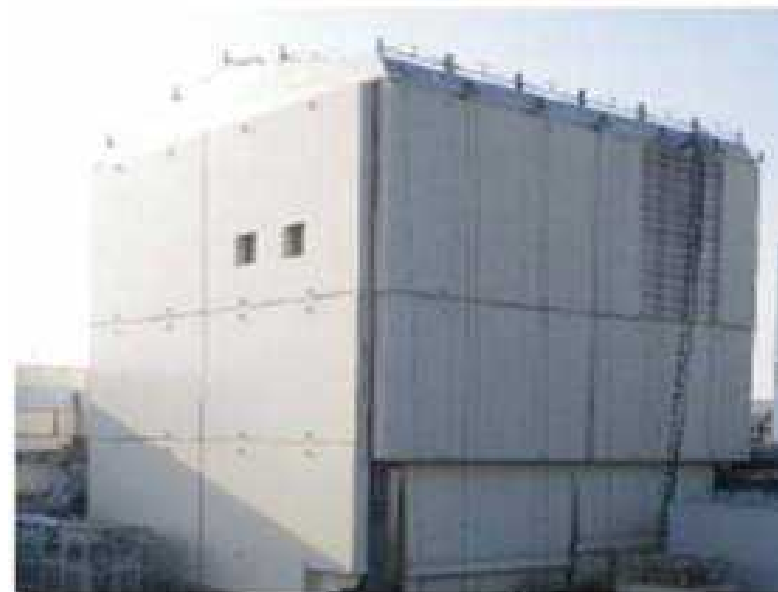
Building cover installed (at present)

Photo taken in December 2014

- Roof panels were replaced after temporary removal (Replacement completed on 4 Dec 2014)

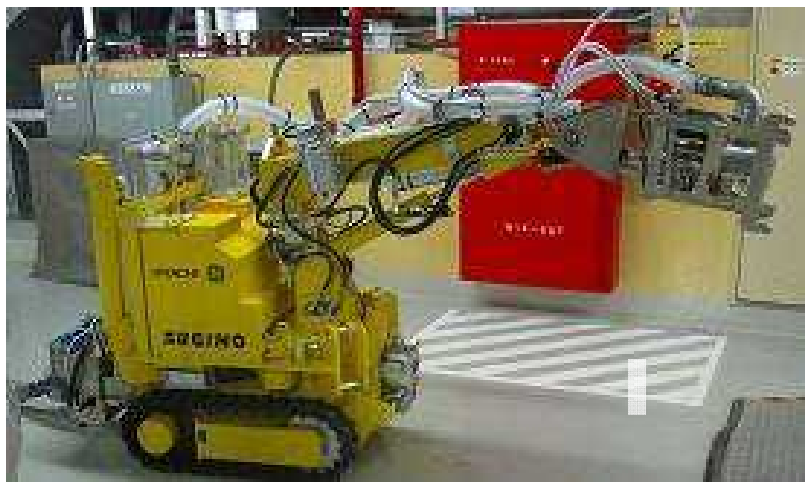
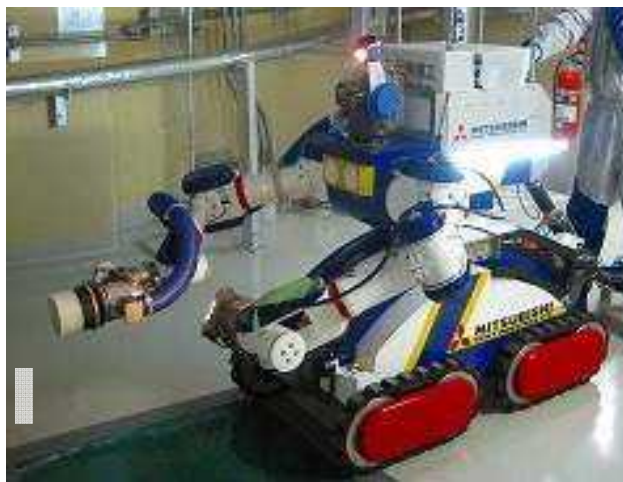
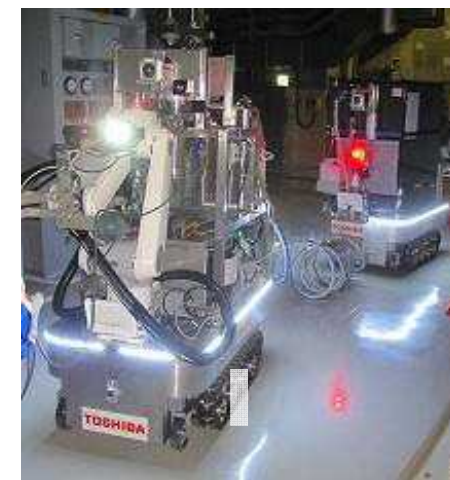
Decontamination robot

As the inside of reactor buildings are highly contaminated, robots for decontamination were developed. (Following photos are robots for lower level)

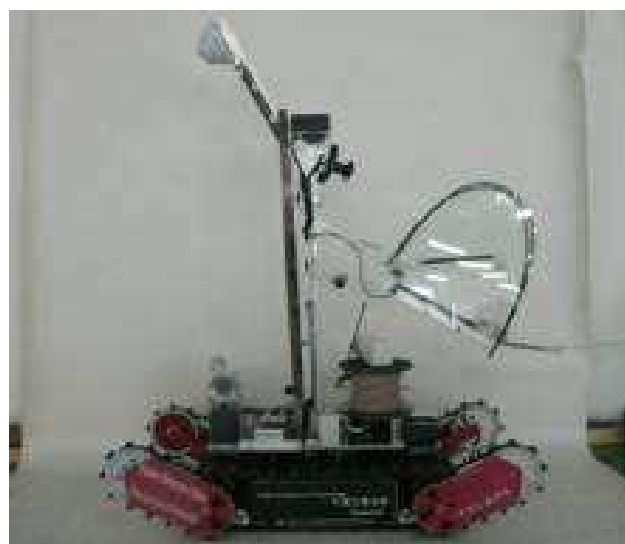
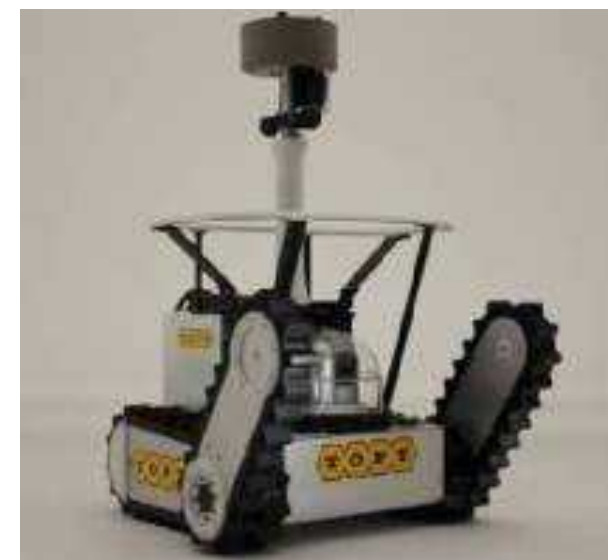
Research robot

In order to measure radiation dose and take photos inside buildings, robots with camera which can move on debris were developed.
