Facts about Earthquake at Kashiwazaki-Kariwa Nuclear Power Station in Japan

Niigata-Chuetsu-Oki Earthquake in Japan

Kashiwazaki-Kariwa Nuclear Power Station

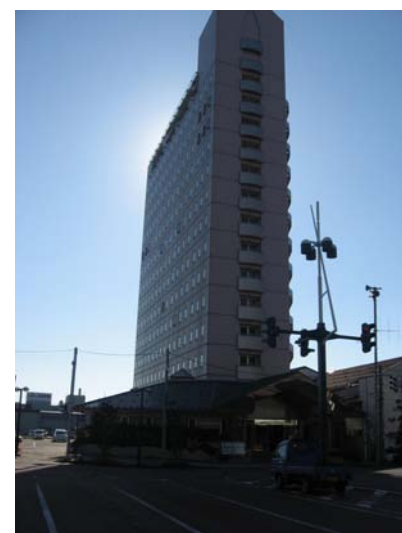
Railway was bent

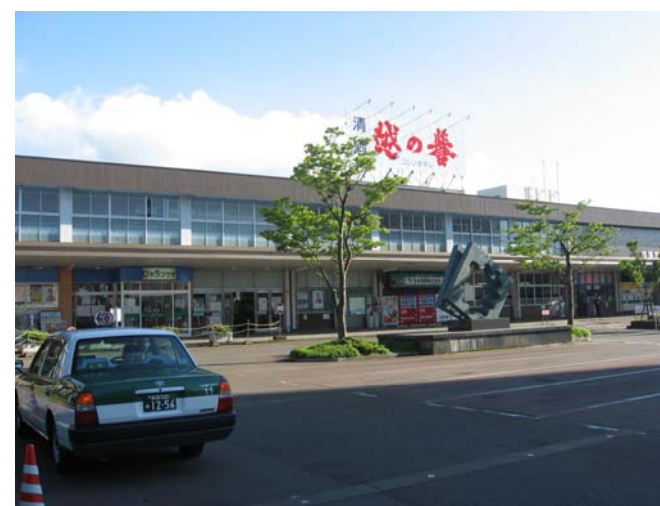
Few Concrete Building were damaged

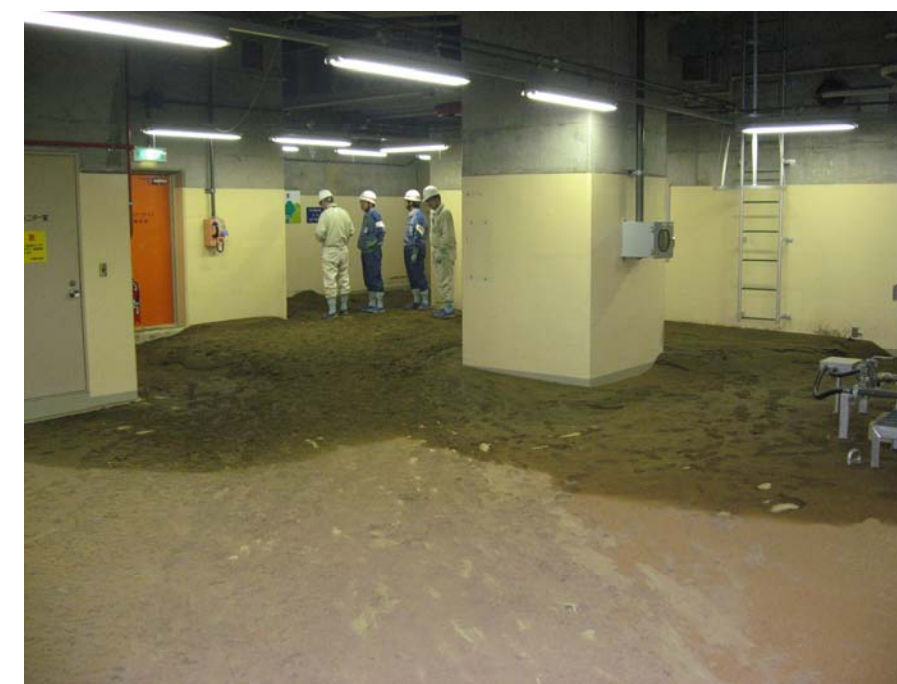
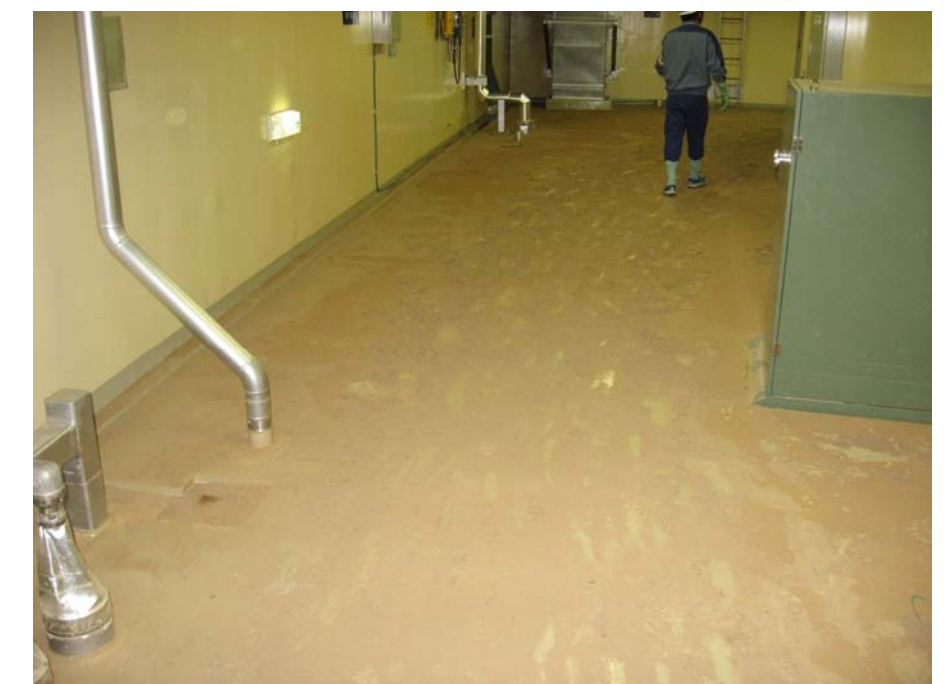
Internal Flooding of Unit 1

- *The fire protection (FP) piping near the building of Unit 1 was damaged, and the FP water flowed into the Reactor Combination Building of Unit 1.
- *Approximately 2,000m³ FP water accumulated at the bottom floor.
- *Many of equipment for the waste disposal are installed on the bottom floor of the Reactor Combination Building. However, it seemed that the flood didn't submerge the safety-related equipments such as Emergency Core Cooling System (ECCS) of the Reactor Building.

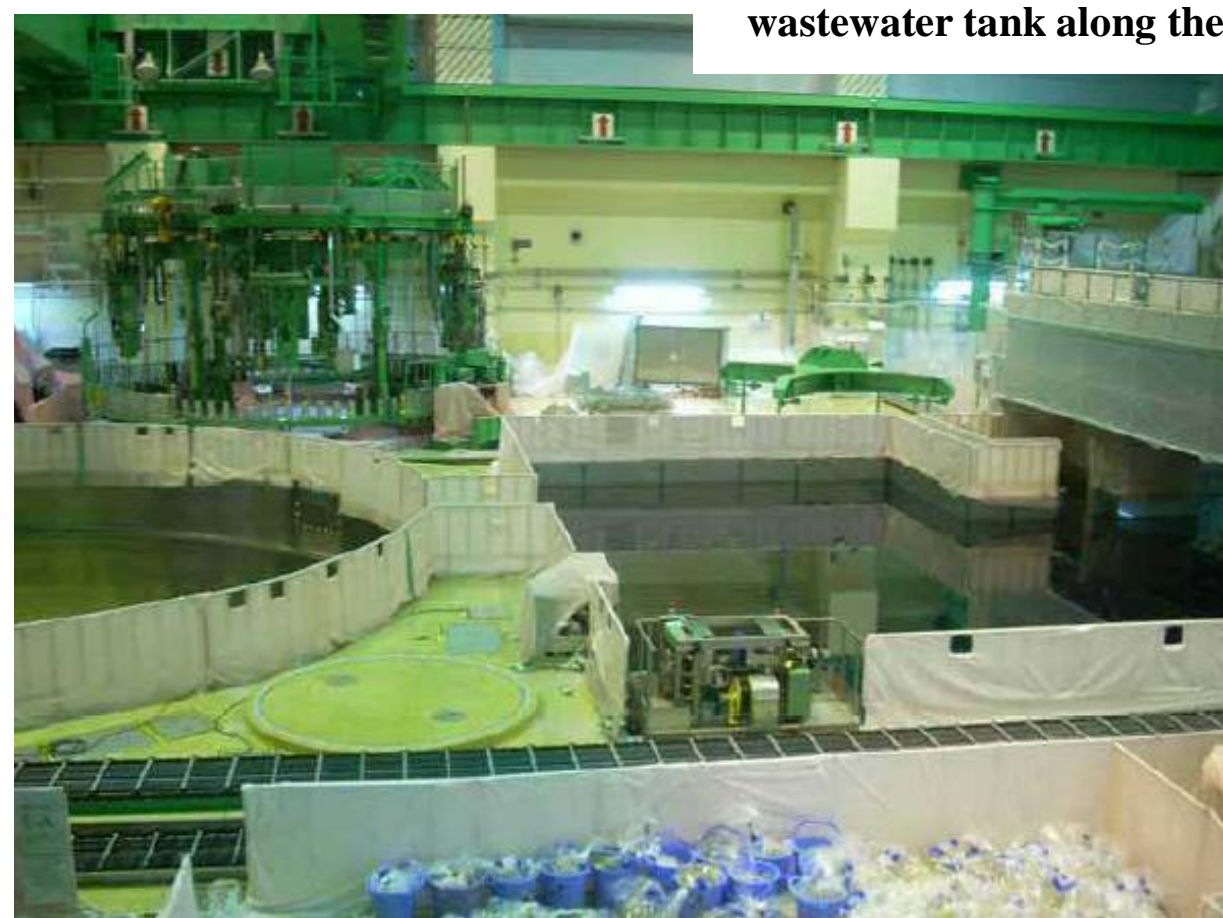
Water of Spent Fuel Pool released from Unit 6

- *Water of Spent Fuel Pool sloshed by earthquake, and splashed on the operating floor.
- *Splashed water was released through the cable penetration of the Refueling Platform to the Sea.
- *Exposure dose would be 2×10^{-9} mSv and substantially lower than 1 mSv, the legally-defined limit of radiation dose to the public per annum.

Overview of Operating Floor

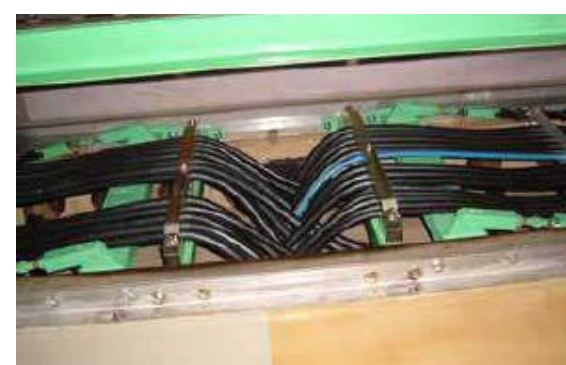
Cable Junction Box

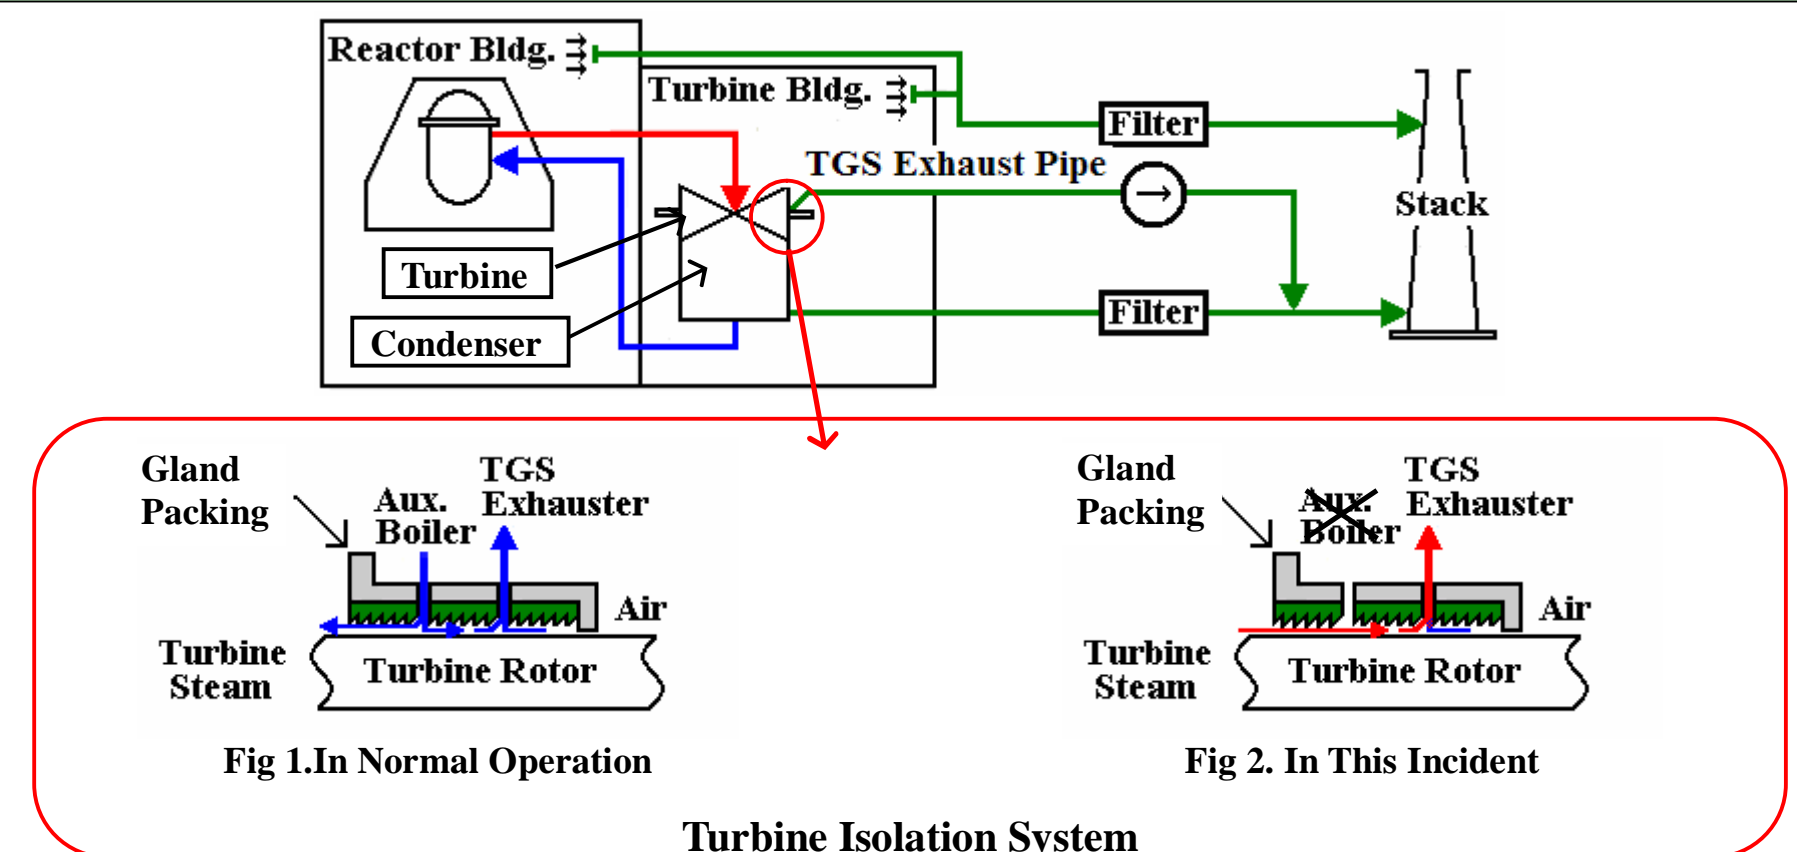
Radioactive Gas in Low Pressure Turbine released from Unit 7

- *Turbine Gland Steam (TGS) which seals Turbine System is specially supplied from the Auxiliary Boiler (Aux. Boiler).
- *Aux. Boiler stopped to supply TGS for the turbine system due to the earthquake, and radioactive gas in the turbine and condenser released into the atmosphere through the TGS exhausted pipe.
- *Exposure dose would be 2×10^{-7} mSv and substantially lower than 1 mSv, the legally-defined limit of radiation dose to the public per annum.

- *The cause of the leakage is believed delay of the stop of the TGS exhauster after automatic reactor shutdown.
- *The TGS exhauster normally exhausts supplied TGS (blue line of Fig 1). But in this incident, TGS exhauster was continuously in operation, though TGS was stopped to supply.
- *It is suspected that the iodine and radioactive gas in the turbine, were blown out by the TGS exhauster (red line of Fig 2), and released into the atmosphere through the stack.
