The Present Status and the Future Of Fukushima Daiichi NPS

April 18th, 2012
Zengo Aizawa
Tokyo Electric Power Company

The Earthquake and the Tsunami of the 3/11/2011

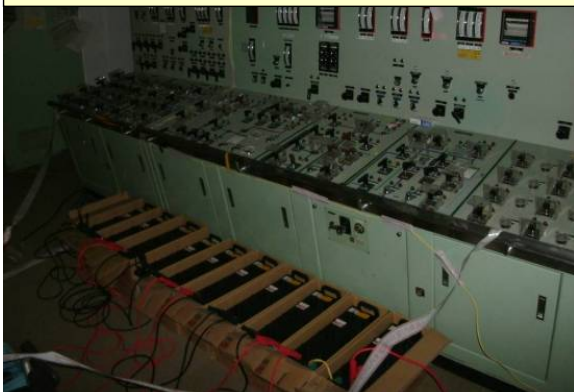
Car Batteries connected to the Instruments Panel

instrument Reading with a flashlight
