## The Kashiwazaki Kariwa NPS Today: Three Months after the Earthquake

Three months have passed since the Niigata-Chuetsu Offshore Earthquake struck. This report will look at the effects of that temblor on the world's largest nuclear power plant, the Kashiwazaki Kariwa Nuclear Power Station (NPS) of the Tokyo Electric Power Co. (TEPCO). The NPS is composed of seven units, with a total output of 8,212MW.

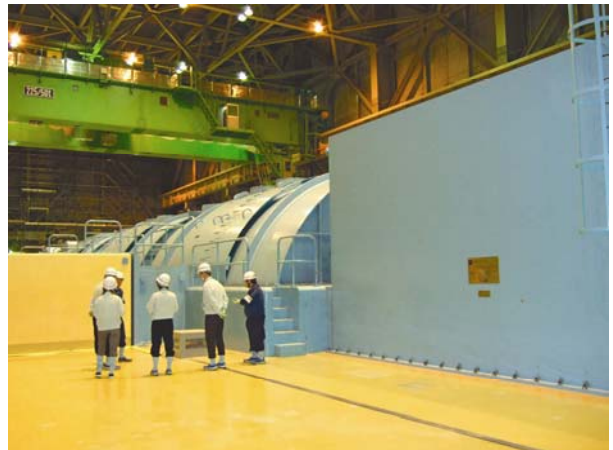
An earthquake meter (lower center) in the upper part of the turbine mount of Unit 3, which experienced the greatest earthquake acceleration in the July 16 quake. The acceleration experienced was measured at 2,058gal (in an E-W direction), some 2.5 times the design acceleration of 834gal.

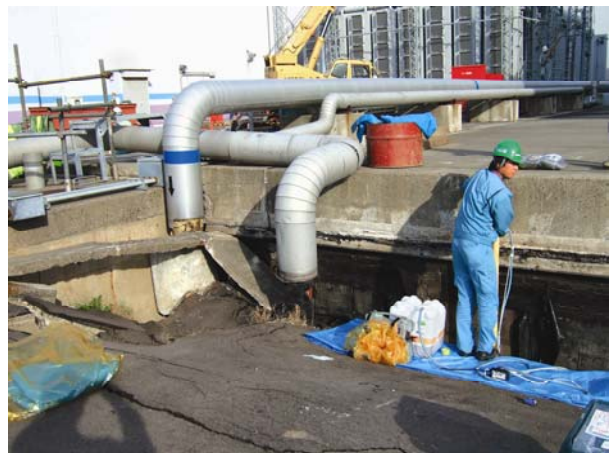
An area where the ground subsided by approximately one meter. Within the NPS's perimeters, interim restoration work has been done on the roads, making them passable, but even now, work to repair ground subsidence, etc., on the roads is taking place everywhere.
