# Events and highlights on the progress related to recovery operations at Fukushima Daiichi Nuclear Power Station

June 2018

## **Section 2: Decommissioning and contaminated water management at Fukushima Daiichi NPS**

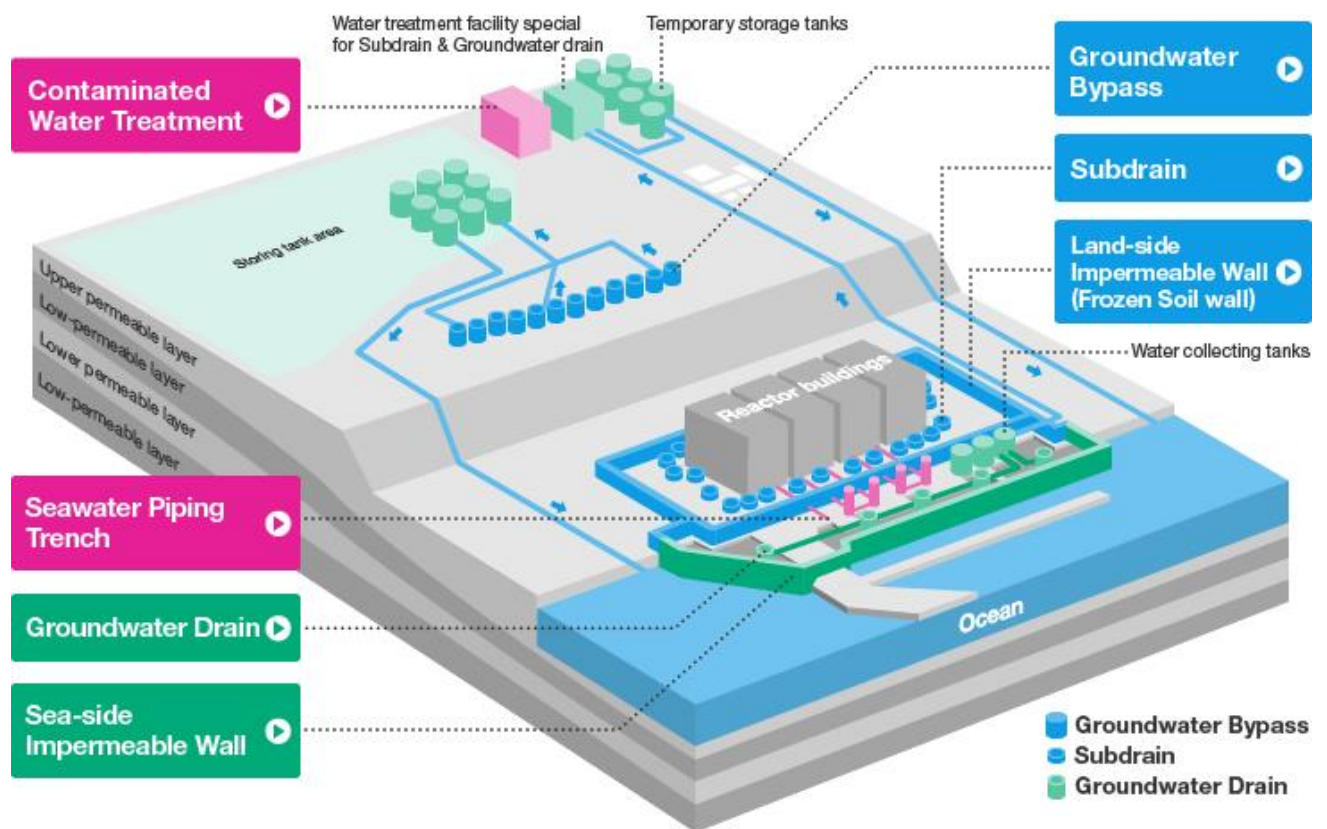
The preventive and multi-layered measures against contaminated water issue are implemented based on the three principles; “Remove sources of contamination”, “Isolate water from contamination” and “Prevent leakage of contaminated water”.

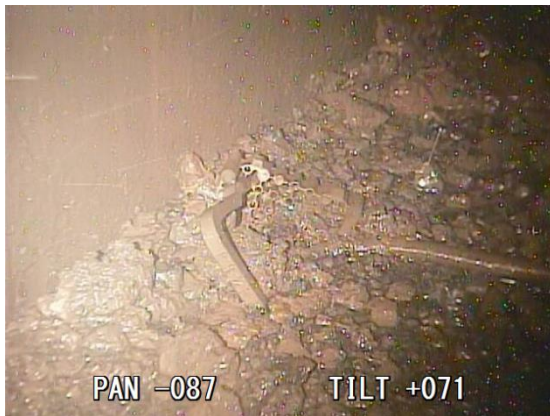
Bottom of the pedestal

Images obtained in the investigation inside the Unit 2 Primary Containment Vessel (PCV) in January were analyzed and from the analytical results, deposits probably including fuel debris were found at the bottom of the pedestal. The deposit was considered to maintain a stable cooling status by injected cooling water based on the following facts: cooling water was falling to the bottom; and the temperature was measured at around 20°C. In addition, multiple parts of deposits higher than the surrounding deposits were also detected. We presumed that there were multiple routes of fuel debris falling. No significant distortion or damage was detected in the bottom structures such as support columns and inner wall faces of the pedestal.

On January 19, 2018, the status below the platform inside the pedestal was investigated using an investigative device with a hanging mechanism. From the analytical results of images obtained in the investigation, deposits probably including fuel debris were found at the bottom of the pedestal. In addition, multiple parts of deposits higher than the surrounding deposits were also detected. We presumed that there were multiple routes of fuel debris falling. There have been no changes in the temperature and pressure inside PCV and the reactor maintains a stabilized condition. The result of this investigation does not mean that some new phenomenon inside the PCV has occurred. Moreover, the inside of the PCV is shielded by thick steel vessel, concrete and zinc-plate inside the building. In addition, there are no significant changes in radiation levels of monitoring posts and dust monitoring at the site boundaries of

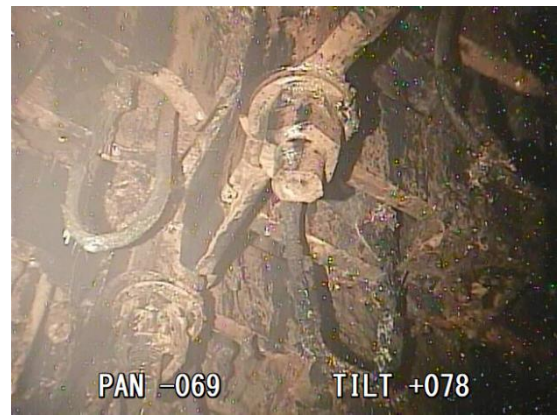
Under the RPV

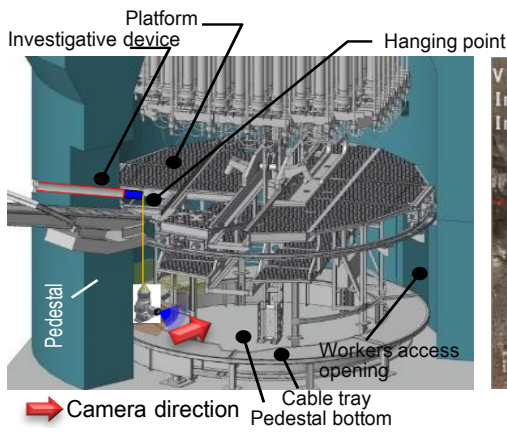
Investigative status (image)

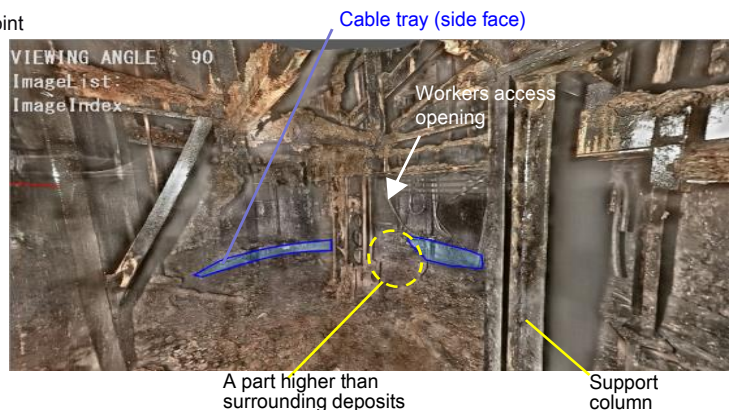
Bottom of the pedestal

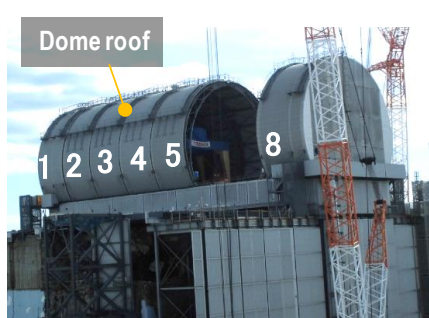
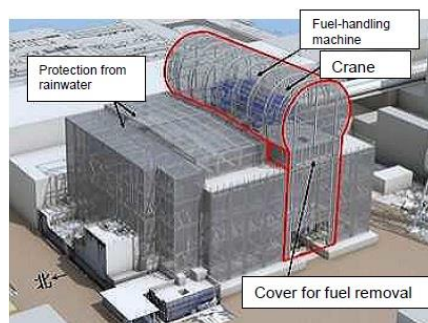
(December 19, 2017)

Image of the cover for fuel removal at Unit 3

#### 3. Installation completion of the Unit 3 fuel removal cover

Installation of all dome roofs for the Unit 3 fuel removal cover was completed on February 23. Work to install power supply cables is currently underway. Following test operation of ventilation facilities, which will reduce the release of radioactive materials inside the cover to air, and the fuel-handling machine, etc., small rubble inside the pool, which may interfere with fuel removal, will be removed. In addition, training to facilitate steady fuel removal will be provided to improve operation skills. Work will continue with safety at first priority toward fuel removal in around mid-FY2018.

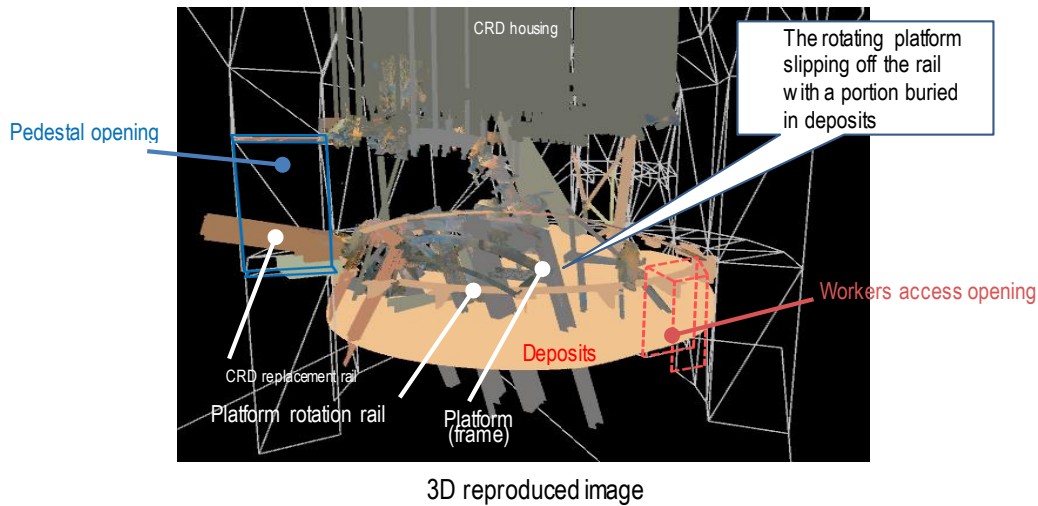
To understand the overall picture inside the pedestal, videos obtained while investigating inside the Unit 3 PCV in July 2017 were reproduced in 3D. Based on the reproduced images, the relative positions of the structures, such as the rotating platform slipping off the rail with a portion buried in deposits, were visually understood. Consideration toward fuel removal, such as utilizing these results in the equipment design, continues.

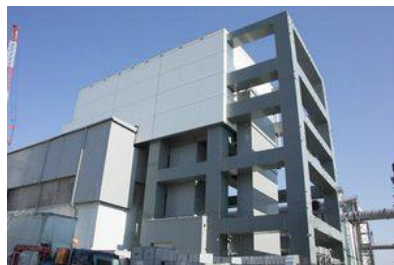
Equipment for fuel removal

In spite of a hydrogen explosion, the fuel assemblies of Unit 4 were not damaged, as the plant was in cold shutdown status and all the fuel had been stored in the spent fuel pool before the accident. The fuel assemblies in the pool were taken out and transferred to the common pool located within the station site. This fuel removal operation started on November 2013 and was safely completed in December 2014. Fully utilizing this successful experience, the fuel assemblies remaining in the spent fuel pools of Units 1, 2 and 3 will be removed.

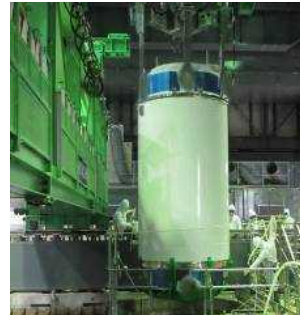
Storage of removed fuel
