The Present Status and the Future Of Fukushima Daiichi NPS

April 18th, 2012
Zengo Aizawa
Tokyo Electric Power Company

The Earthquake and the Tsunami of the 3/11/2011

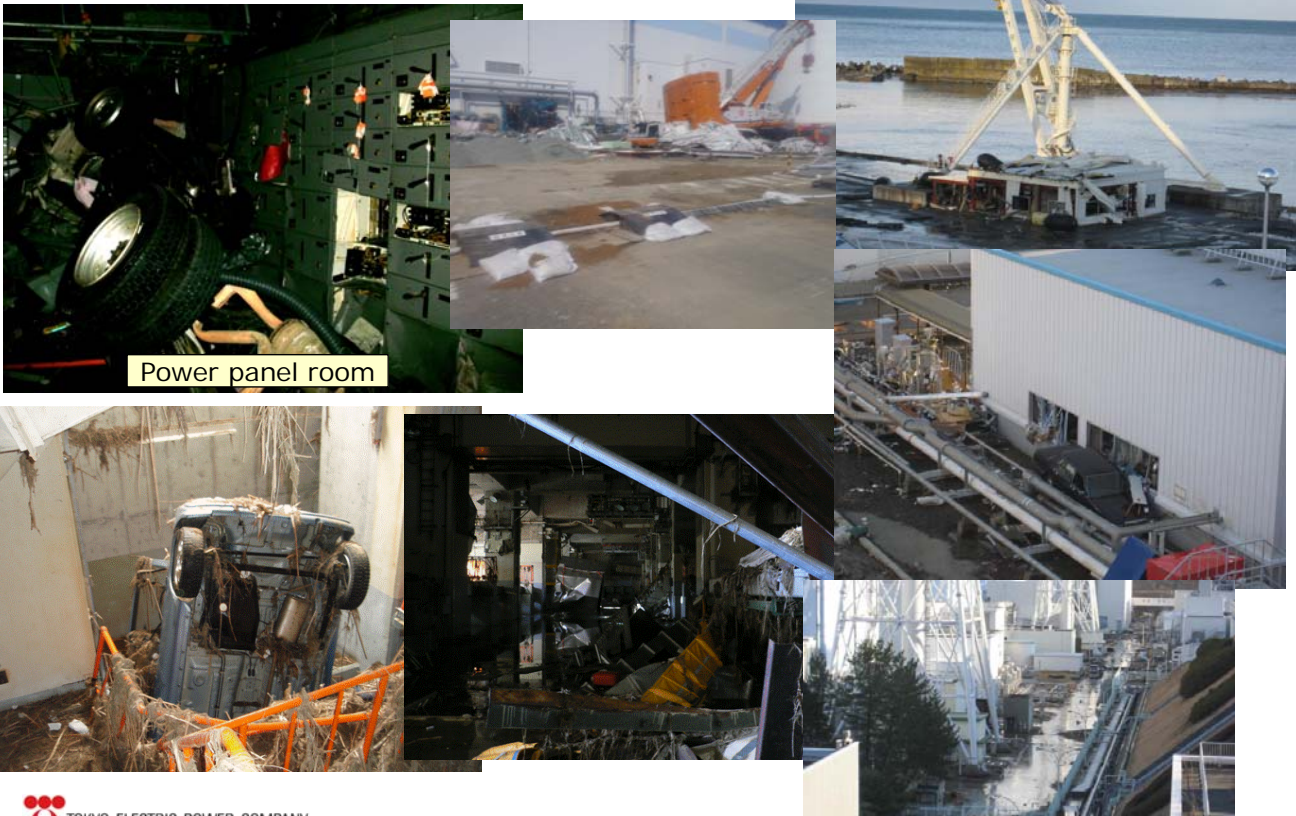
⇒ Inundation to Rooms for Emergency Diesel Generators & Electric Panel

Power panel room

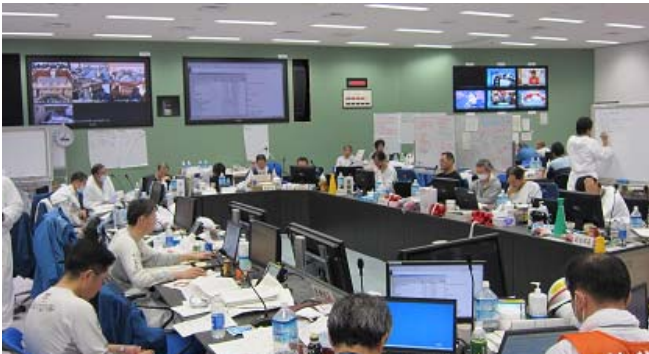
Emergency Response HQ in the anti-seismic building

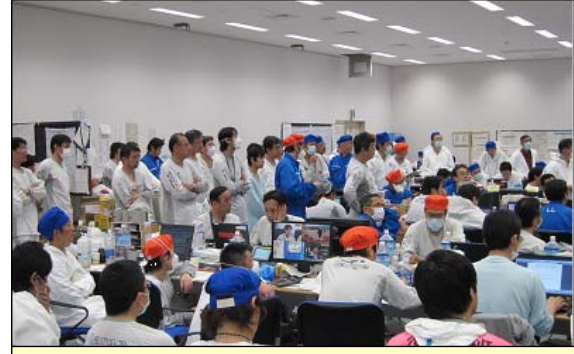
Emergency Response HQ packed with people immediately after the accident
